# **Sample Roof Inspection Report**

**123 Your Roof Avenue**

# Inspection Report

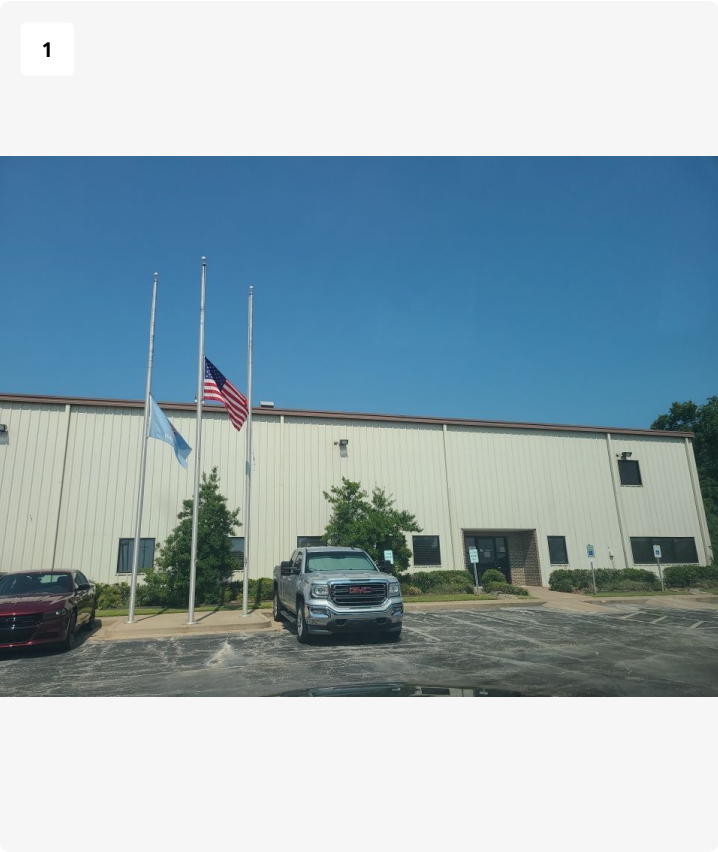
Front of facility

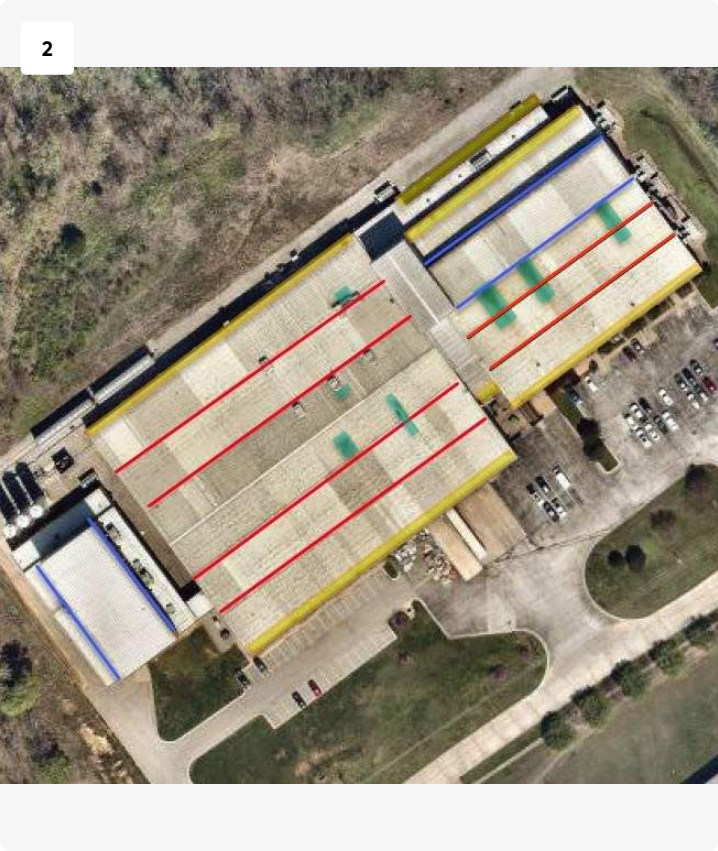
Overview of building

- 1. Yellow: Rust at edges
- 2. Red: Leak at seams, potential leak point and rust starting at seams
- 3. Blue: Leak at transition areas
- 4. Green: Other rust areas of concern including rust caused by plant emissions

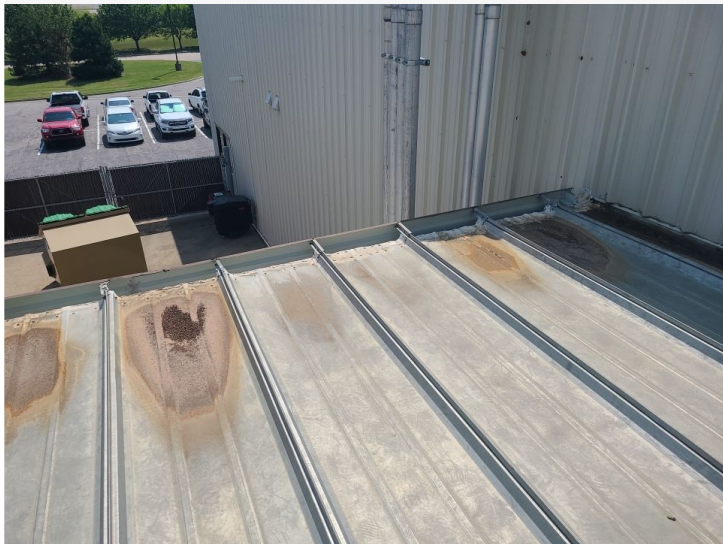
3

YELLOW  
Rust at building edge

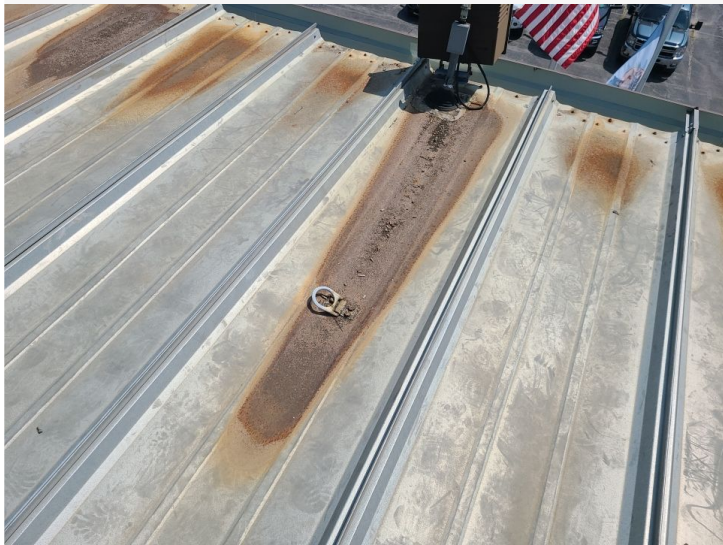
4

YELLOW  
Rust at building edge

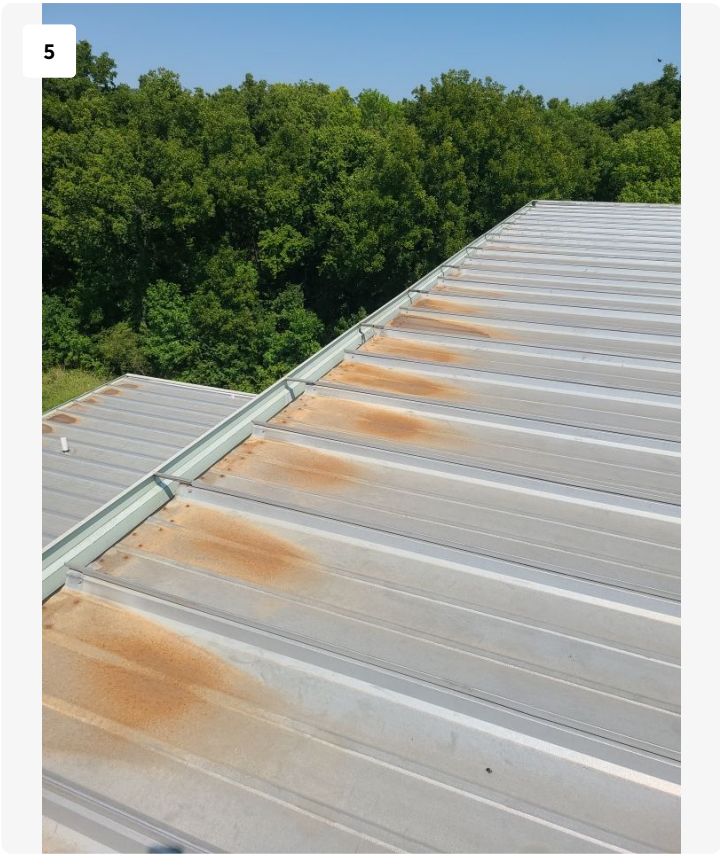
YELLOW  
Rust at building edge

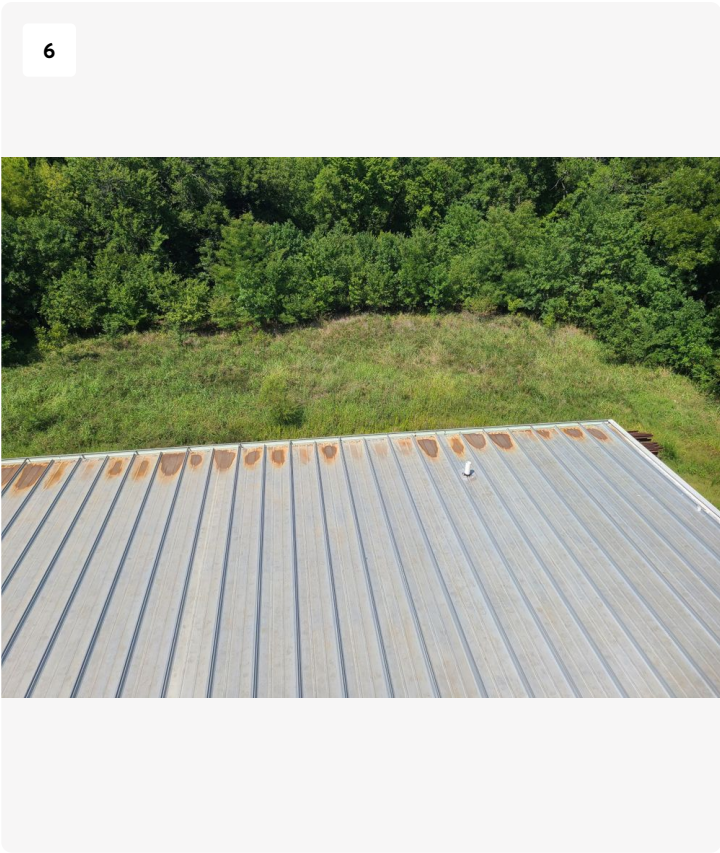
YELLOW  
Rust at building edge

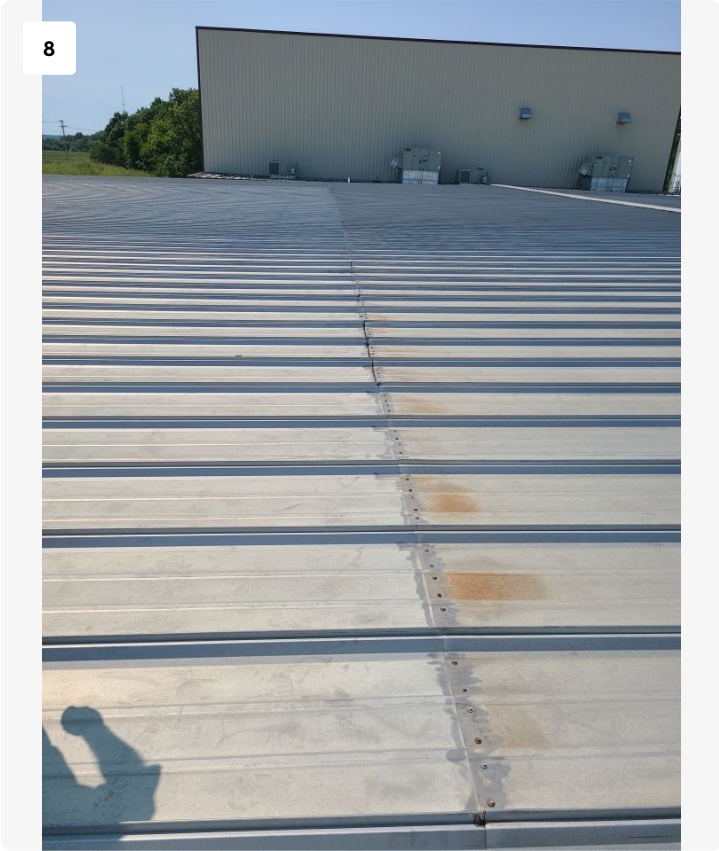
RED  
Seal seam lines and fasteners where leaking  
Rust forming

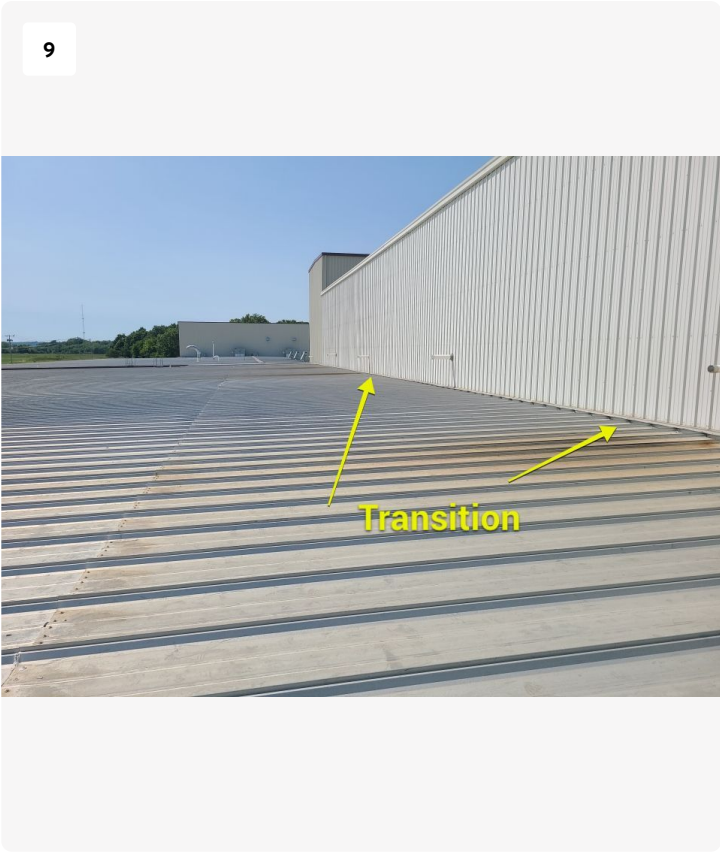
BLUE  
Transition area to be sealed

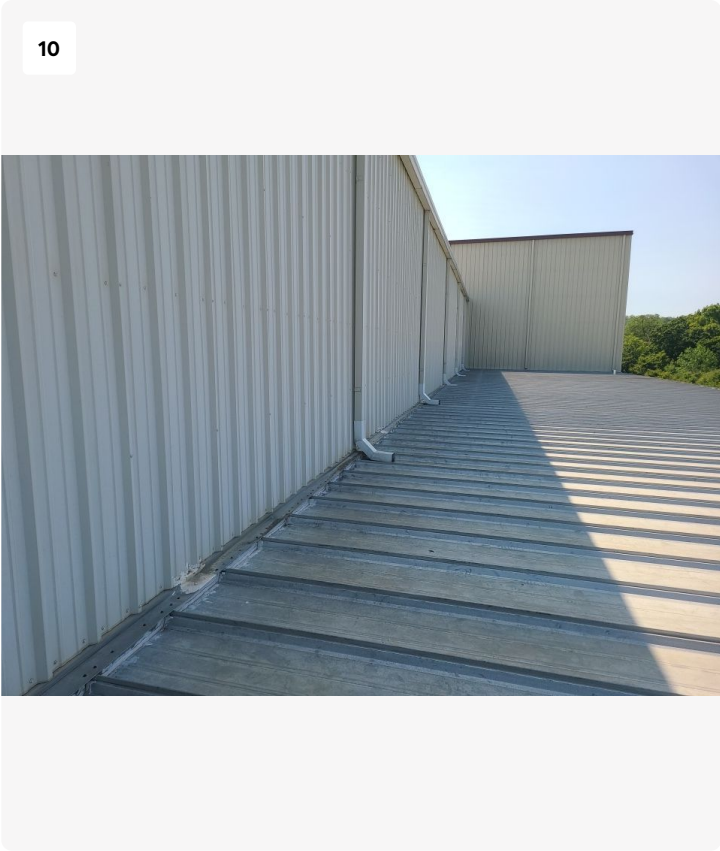
BLUE  
Transition

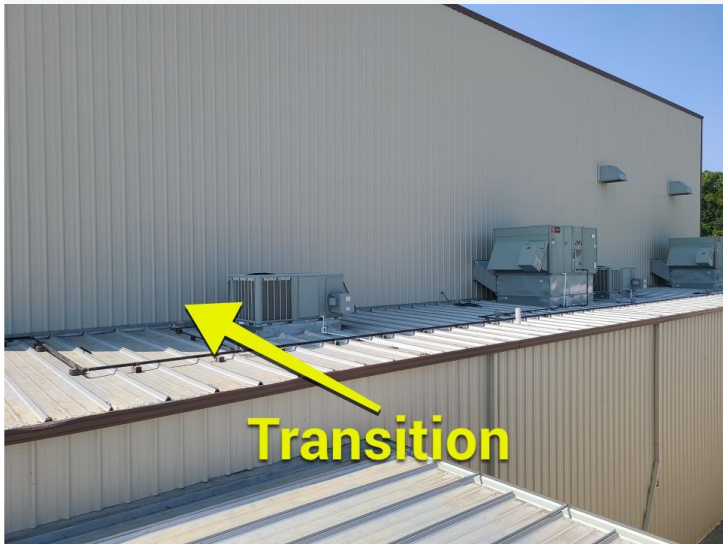
11

BLUE  
Transition here and on the other side of the bay

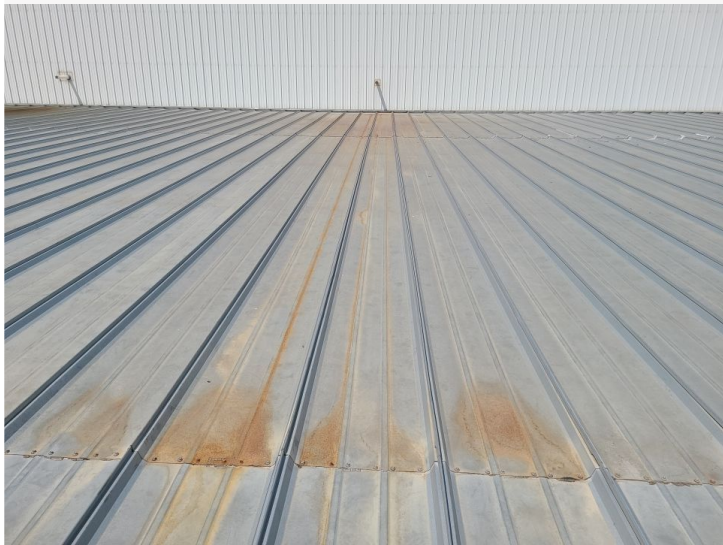
12

GREEN  
Plant emission rust. Seal with primer and add protective sacrificial coating barrier
