**AssetRoof**

# **Roof Condition Assessment**

**Metal Roof System — Seven Sections**

## **Sample Industrial Facility**

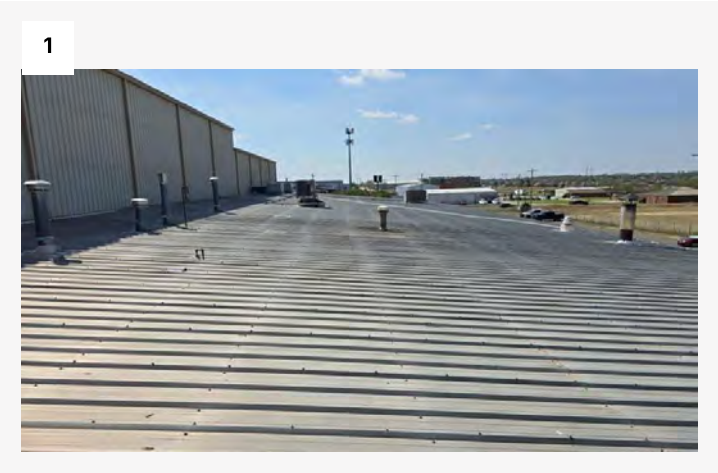
Upper roof transition

Overview of the transition between the tall upper roof and the inspected roof. Leaks have been reported at this transition.

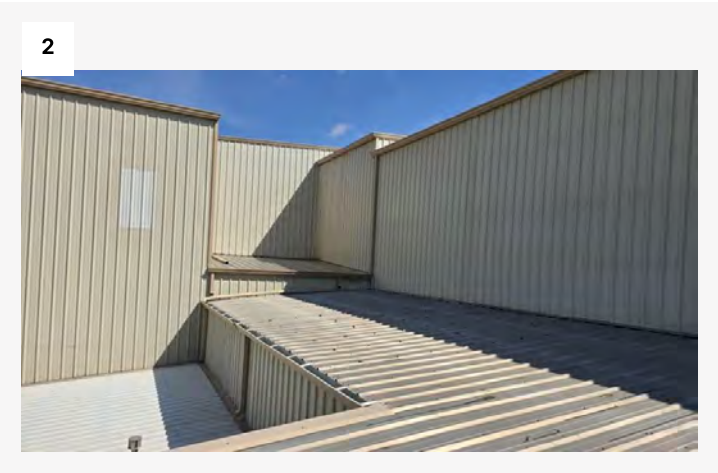
Wall transition

Overview of the wall transition along the same elevation.

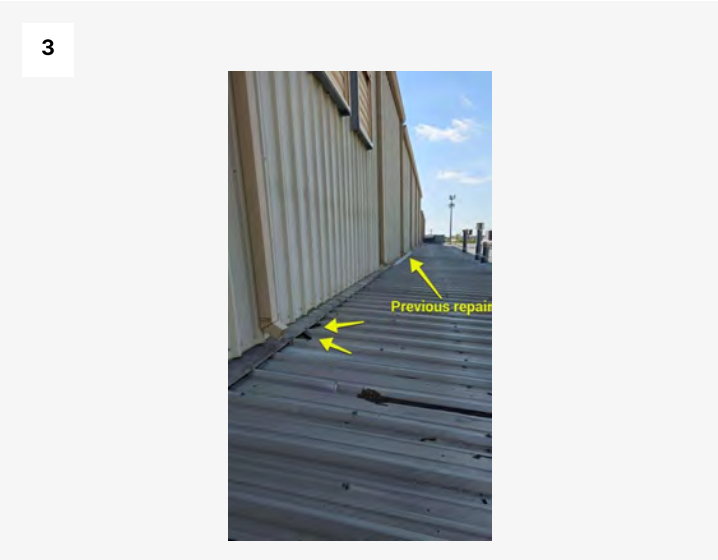
Transition detail

Second overview of the transition condition.

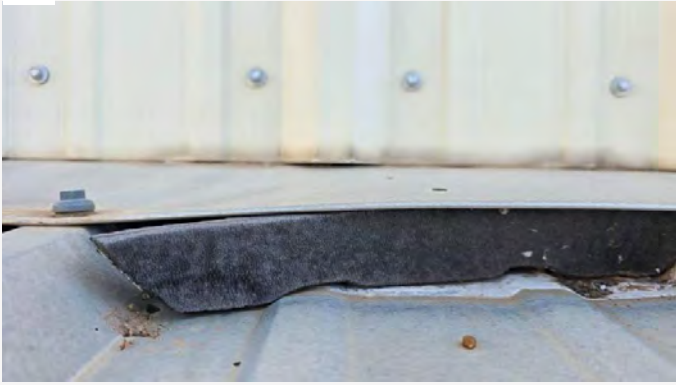
#### **Foam closure displacement**

R-panel foam closure has worked out from under the flashing, leaving the rib openings unsealed.

Sections 1 and 4. Closures have failed along entire elevations. Replace with permanent metal closures set in sealant rather than replacing like for like, which would put the same failure back on the same cycle. This also closes the animal intrusion path documented in Section 1.

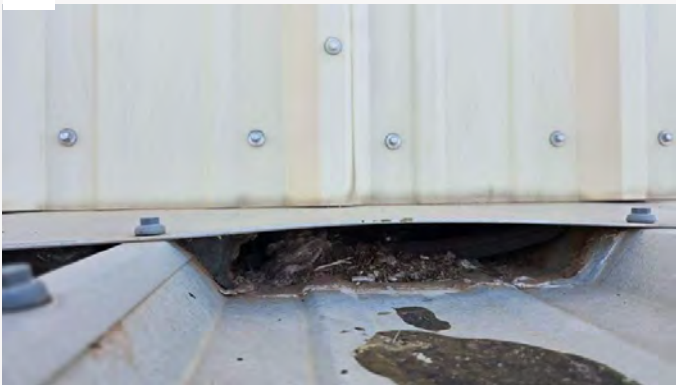
#### **Foam closure displacement**

A second closure pushed out of position. The material shows damage consistent with animal activity rather than weathering alone.

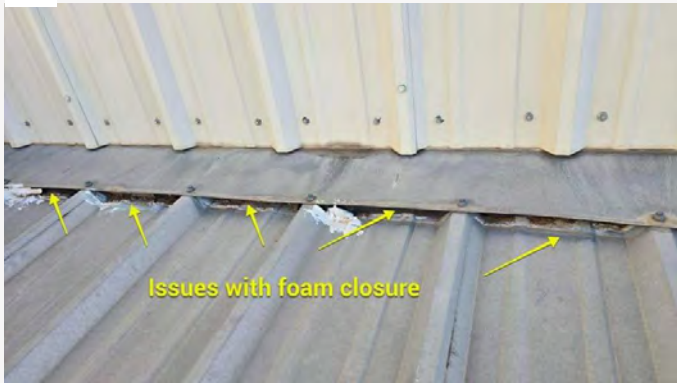
**Field-applied sealant**

Sealant applied over foam closures in a prior repair attempt.

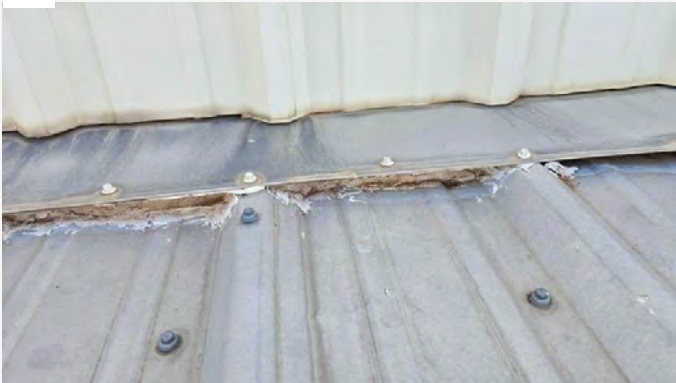
**Prior repair, partial failure**

The sealed closures have failed in part. Foam closures are a consumable detail and will continue to fail on this cycle.

A permanent metal closure with sealant is the corrective detail that addresses both water entry and animal intrusion.

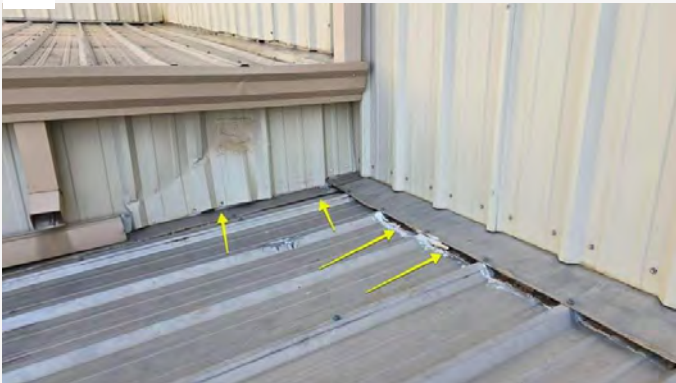
**Wall damage at transition**

Damaged wall with an apparent gap at the transition. Any opening along this line is a potential entry point.

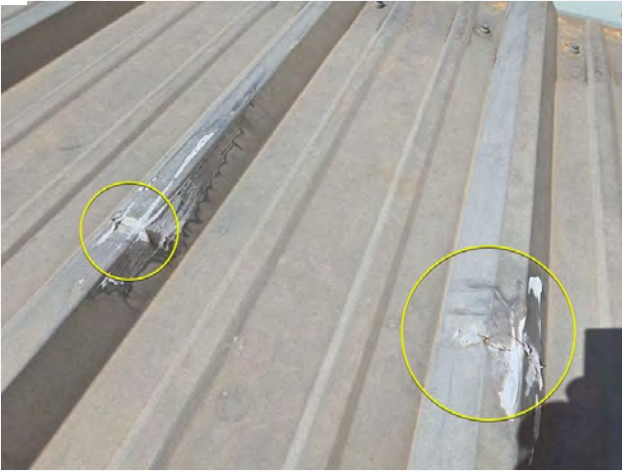
### Failed prior repair

A previous repair at this location has failed and no longer sheds water.

All sections, concentrated in Section 6. Remove failed material rather than applying new sealant over it.

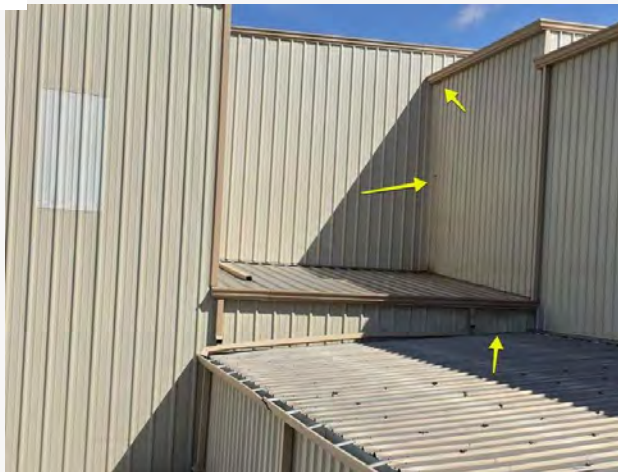
### Transition condition

General condition along the transition. Multiple details in this run warrant attention as a group rather than individually.

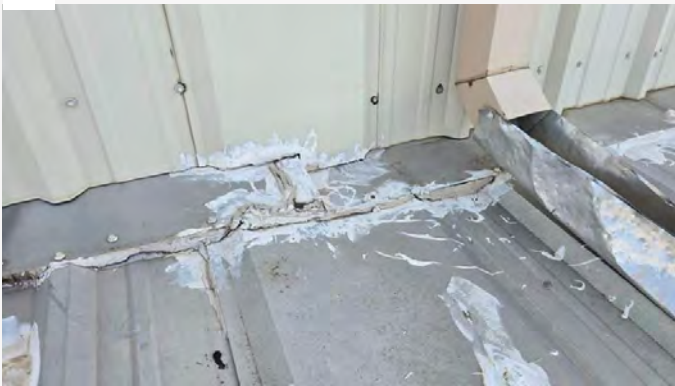
### **Prior repair debris**

Failed repair material remaining on the surface. Removal is required before any new detail is applied.

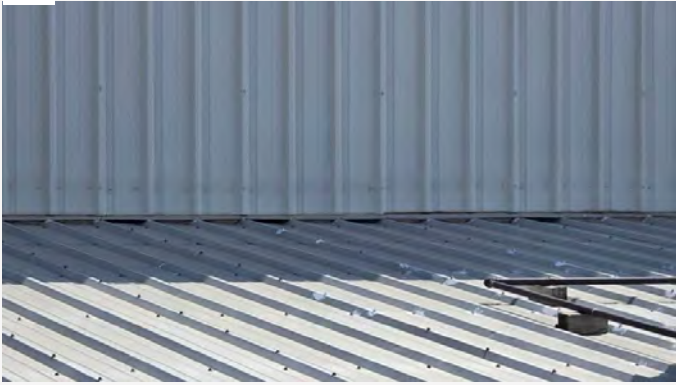
### Closure condition, typical

Closures are missing or damaged consistently along this elevation, not in isolated spots. This is the basis for recommending wholesale replacement rather than spot repair.

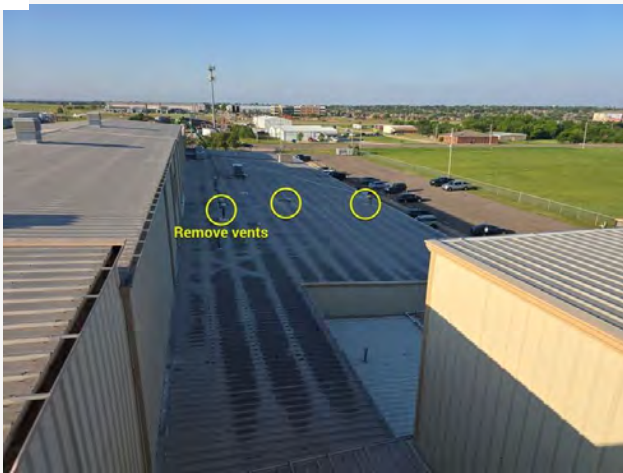
### Abandoned stacks

Four interior vent stacks identified. The owner has indicated these are no longer in service.

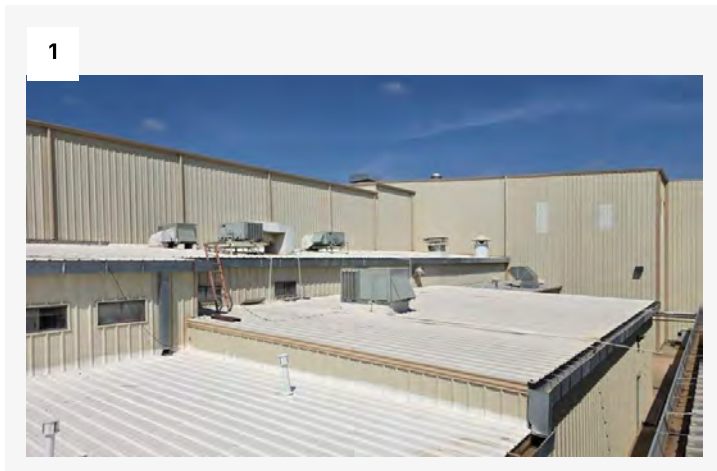
#### Section overview

Overview of the coated section.

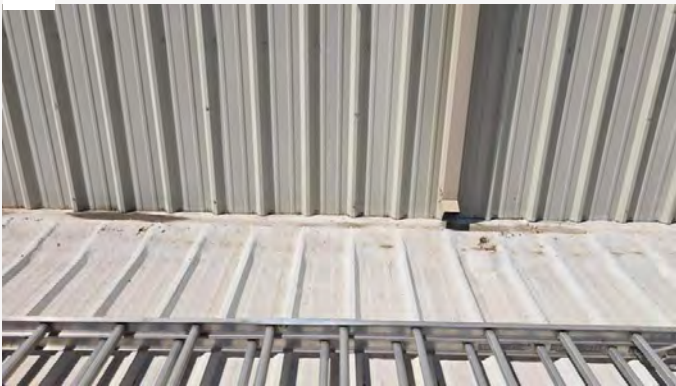
### Coating transition

Coated metal roof with sprayed foam at the transition.

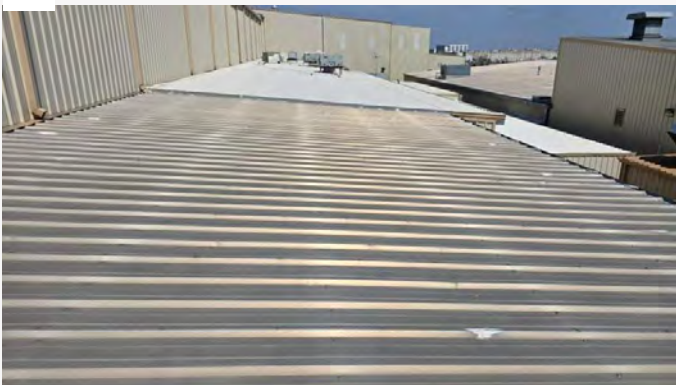
### Metal portion, south end

Metal portion at the south end of the section with several prior repairs visible.

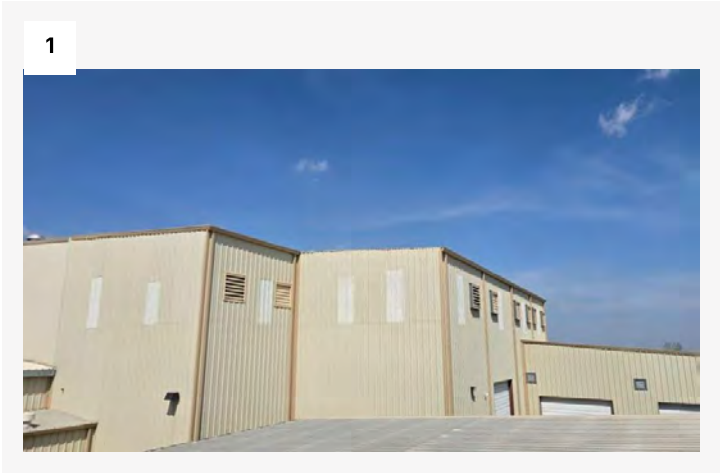
Missing gable trim

A section of the upper roof is missing gable trim, leaving the panel edge exposed.

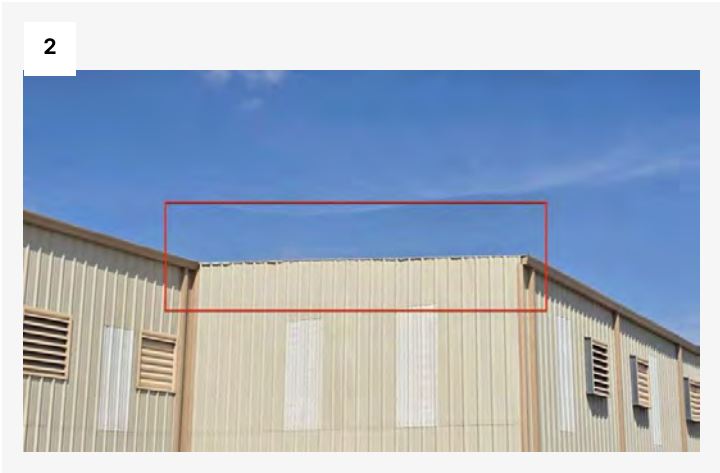
Missing gable trim

Second view of the missing trim run.

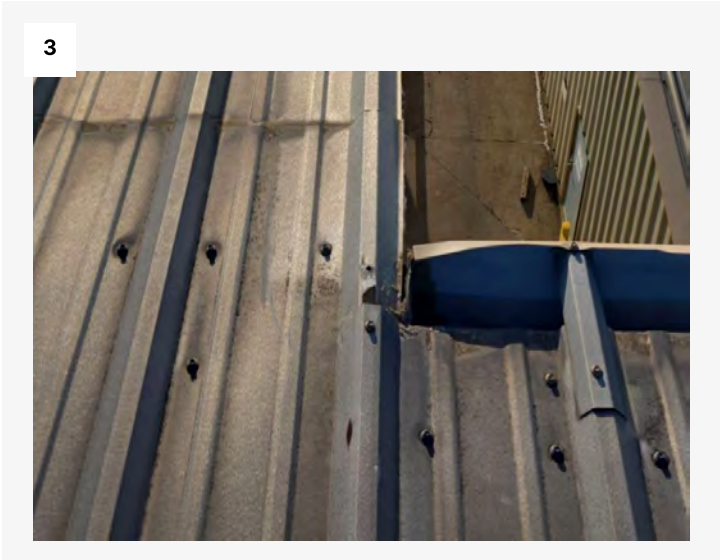
Trim to gutter transition

Transition from the missing gable trim into the gutter.

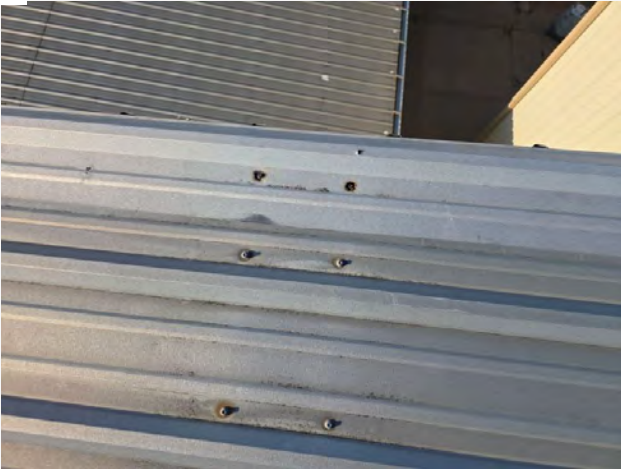
#### **Fasteners rusted through**

Fasteners have rusted through at this location. Replacement fasteners and sealant are required, along with new gable trim.

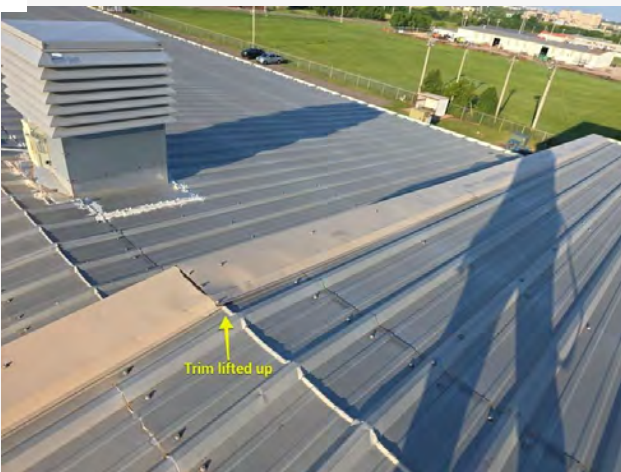
#### **Gable trim uplift**

Gable trim has lifted from the substrate.

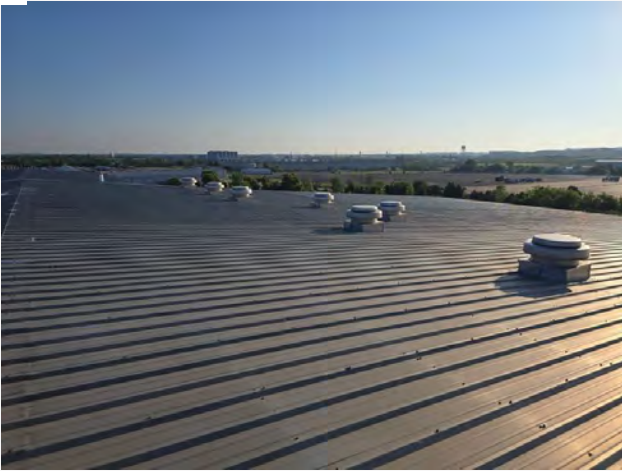
### Vent penetrations

Vent penetrations are a probable leak source in this section. The owner should confirm which units remain in service before any are sealed or removed.

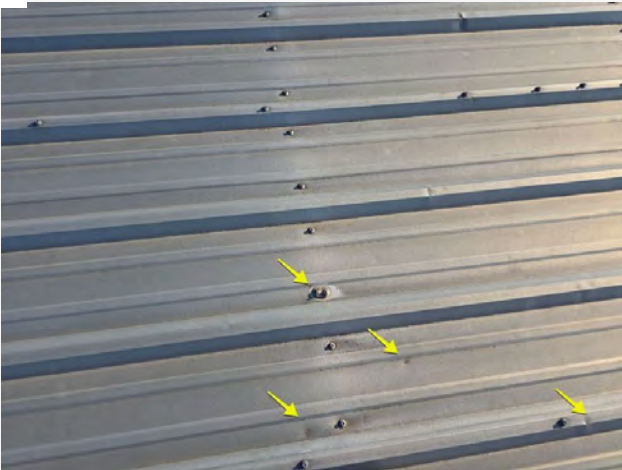
### Poor fastener repair

Fastener repair executed poorly. Hail impact is also visible on the panel surface.

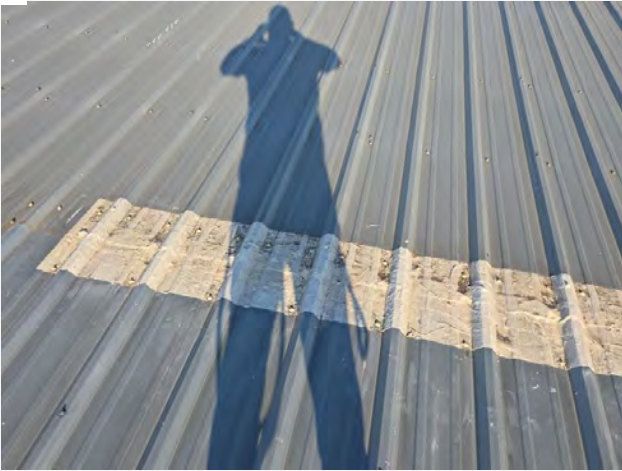
### **Tape seam repair**

Seam repaired with tape. Tape repairs on metal commonly create voids that hold water against the panel and drive corrosion underneath.

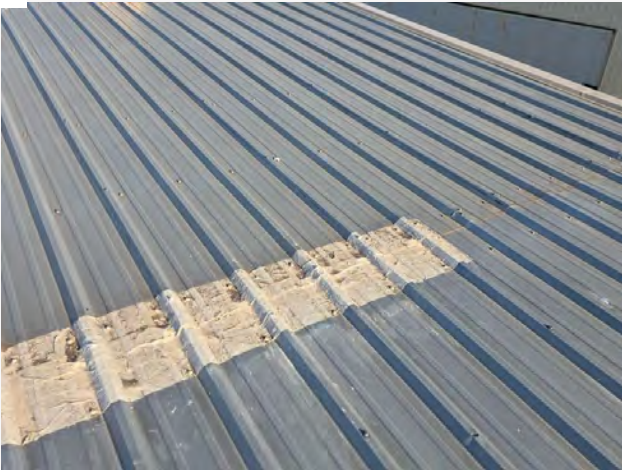
### **Tape seam repair**

Second tape repair with the same exposure.

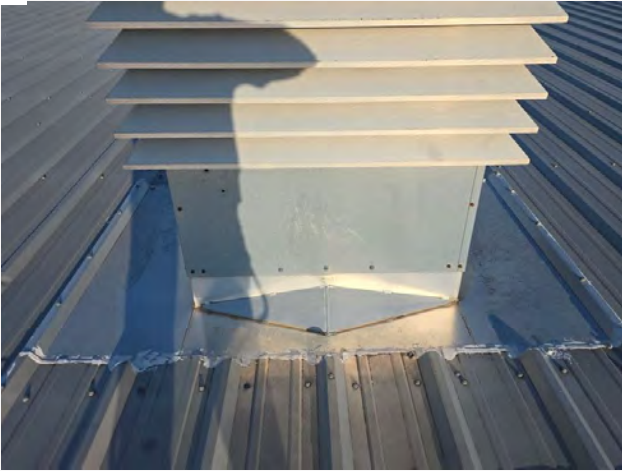
### **Vent sealant condition**

Sealant on the center vents is aged and cracked.

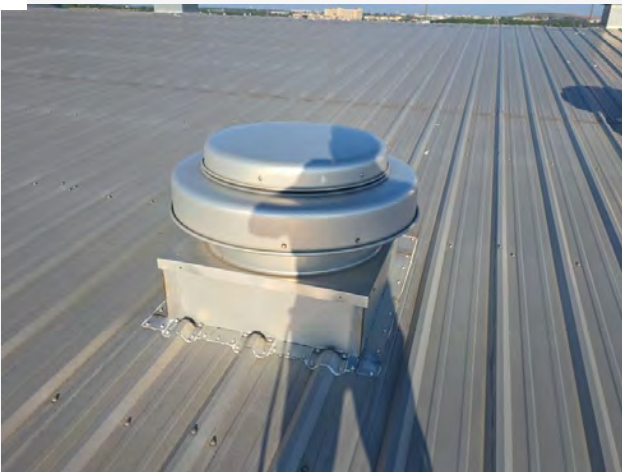
### **Vent sealant condition**

Vent sealant has dried out and is no longer bonded.

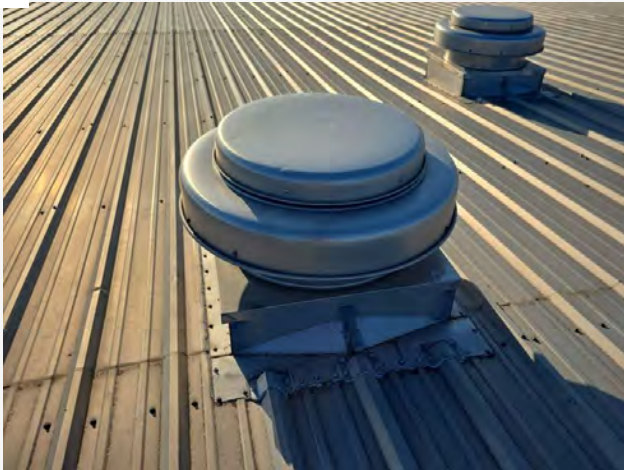
### **Vents, service status**

Vents are a probable leak source. Confirm with the owner which are still required before sealing or removing any.

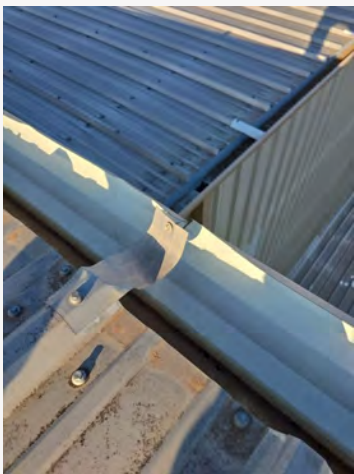
### **Gutter, west side**

Gutter condition on the west side.

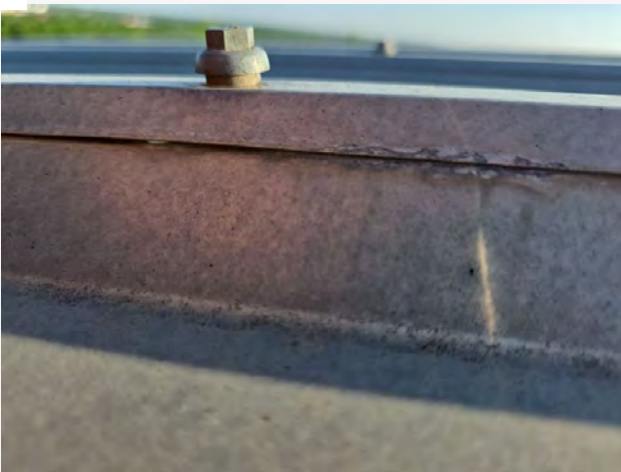
### **Backed-out fastener**

Fastener has backed out of the panel.

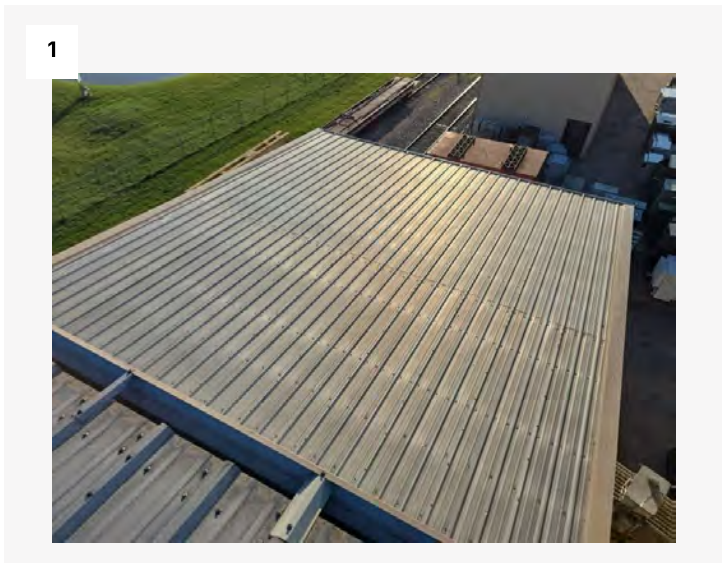
#### Section overview

No major issues observed in the field of this section. General fastener maintenance is required, consistent with the rest of the building.

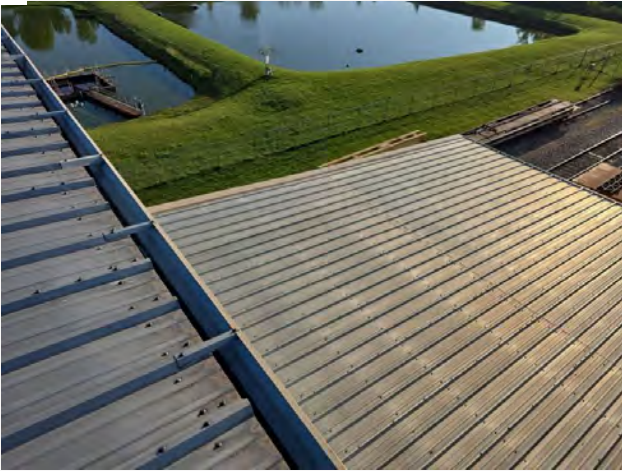
### Gable trim

Gable trim condition issue.

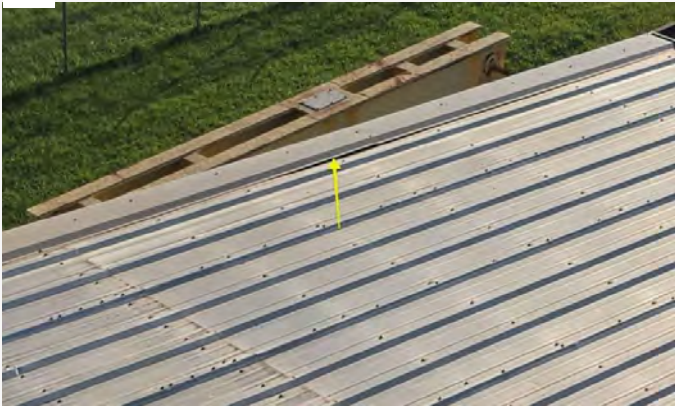
### Gable trim uplift

Wind uplift at the gable trim on the north side of the east roof.

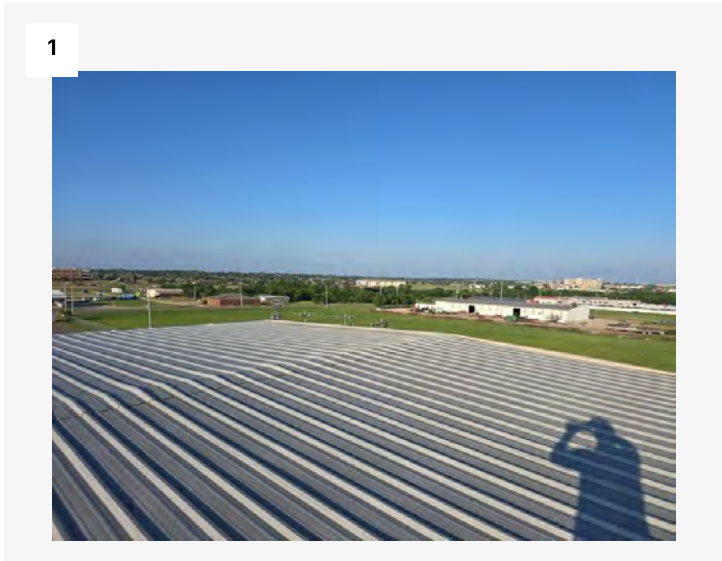
**Section overview**

Overview of the section.

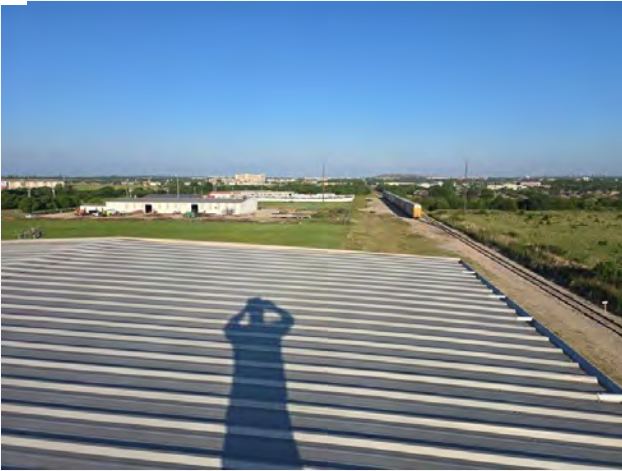
### Prior repair

Prior repair requiring evaluation for whether it is still performing. Fasteners at this location need resealing.

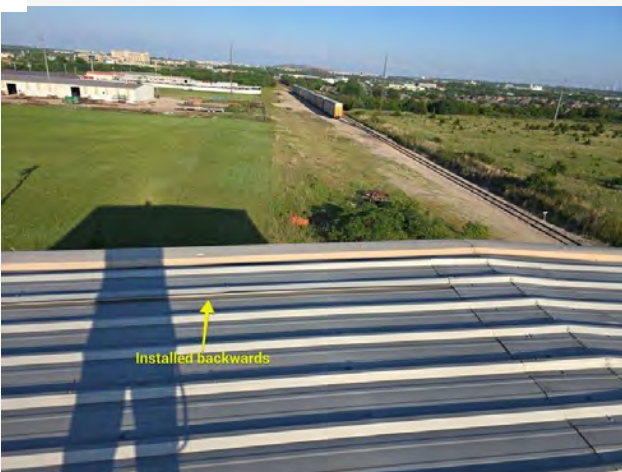
### Reversed panel

One panel is installed in the opposite orientation to the rest of the roof. Whether this was a design requirement or an installation error was not determined.

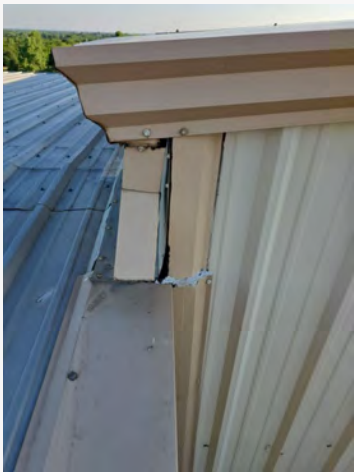
### Fastener condition

General fastener condition across the section.

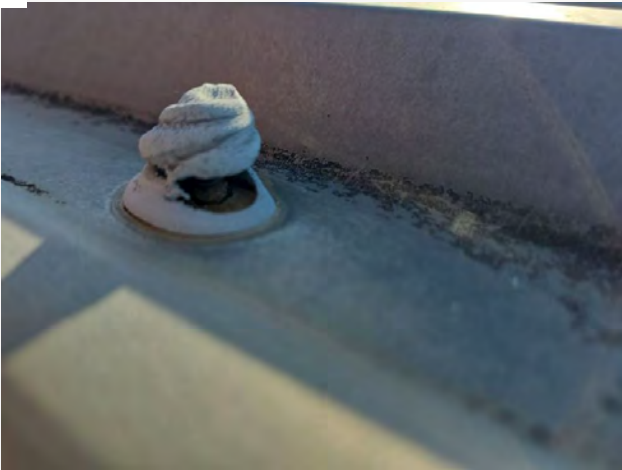
### Fastener condition

Third view of fastener condition.

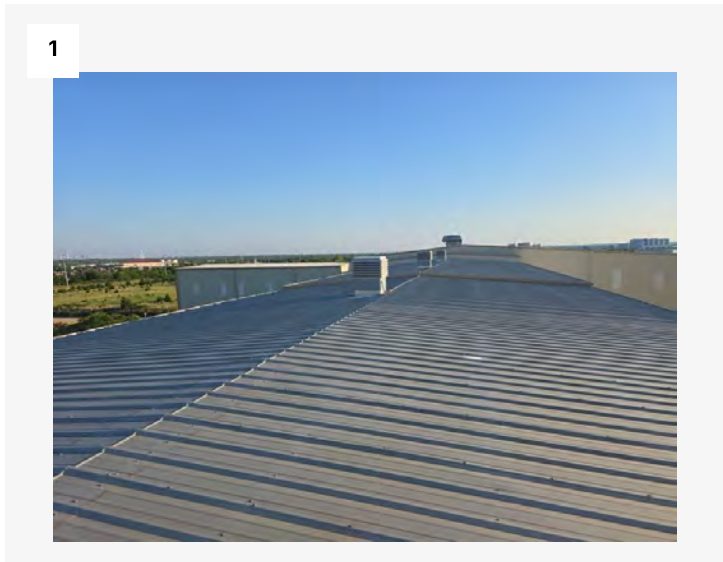
#### Section overview

Overview of the section showing the three center vents.

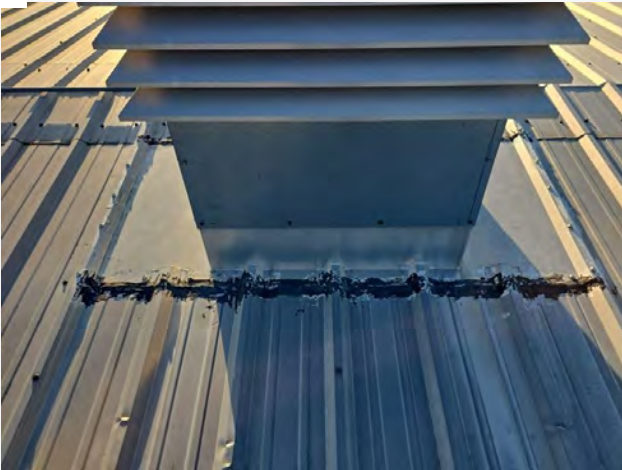
### Prior repairs

Prior repairs requiring resealing.

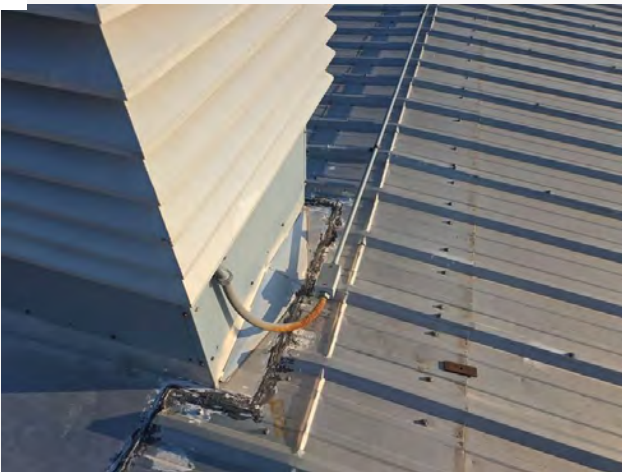
### Prior repairs

Prior repair requiring resealing.

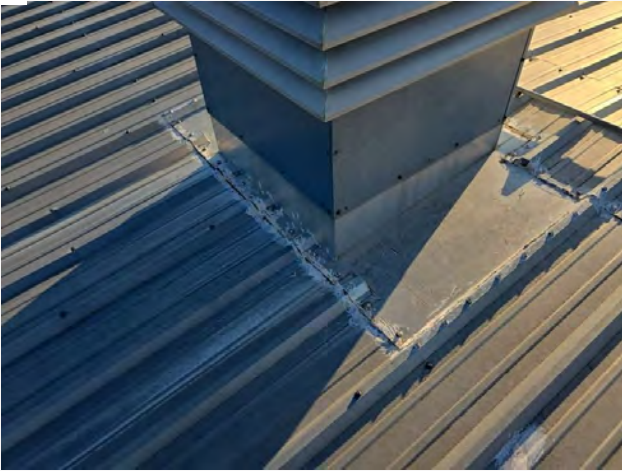
### Prior repairs

Prior repair requiring resealing.

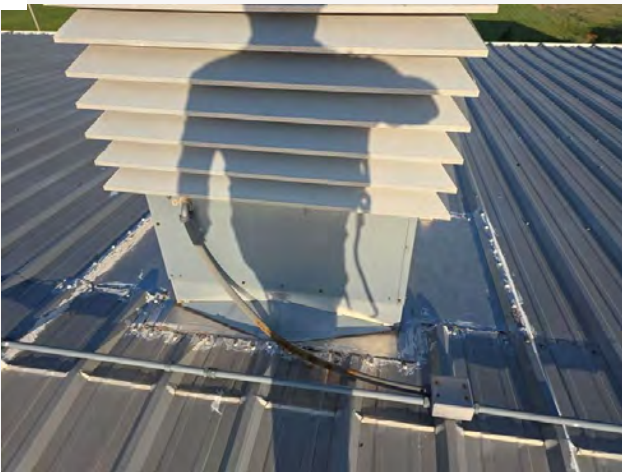
### Prior repairs

Prior repair requiring resealing.

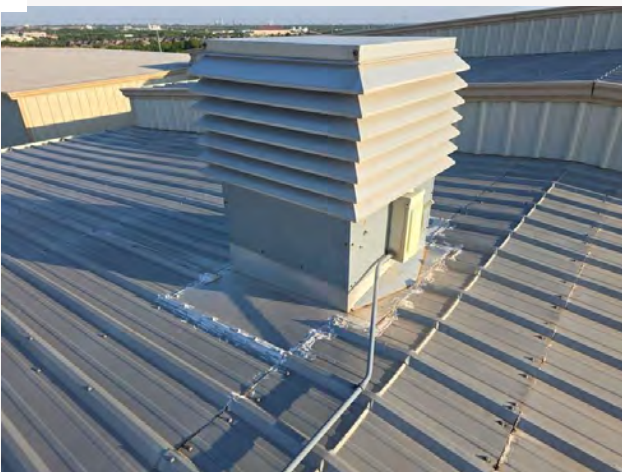
### Prior repairs

Prior repair requiring resealing.

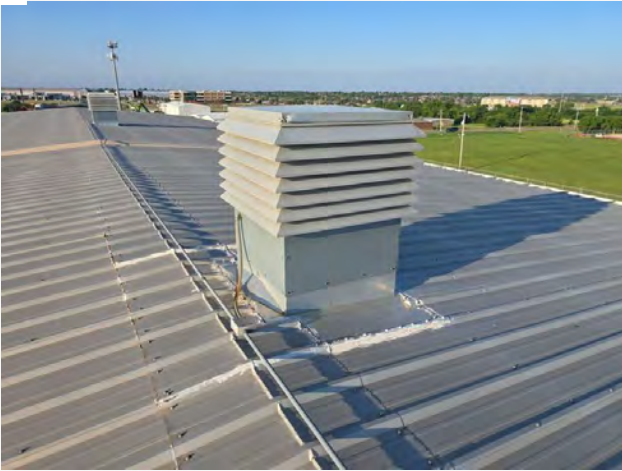
### Prior repairs

Prior repair requiring resealing.

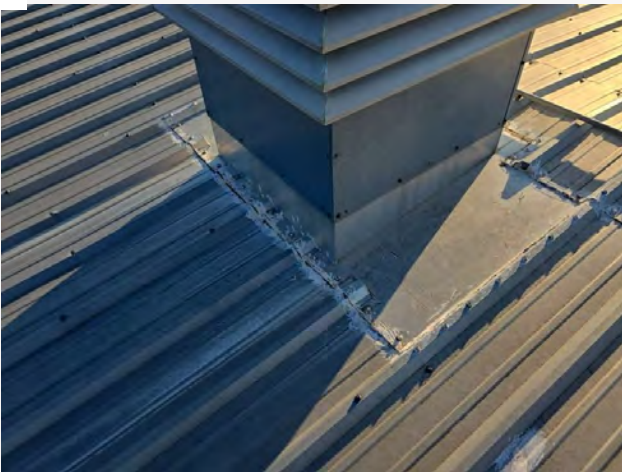
### Prior repairs

Prior repair requiring resealing. The volume of prior repairs in this section is itself a finding.

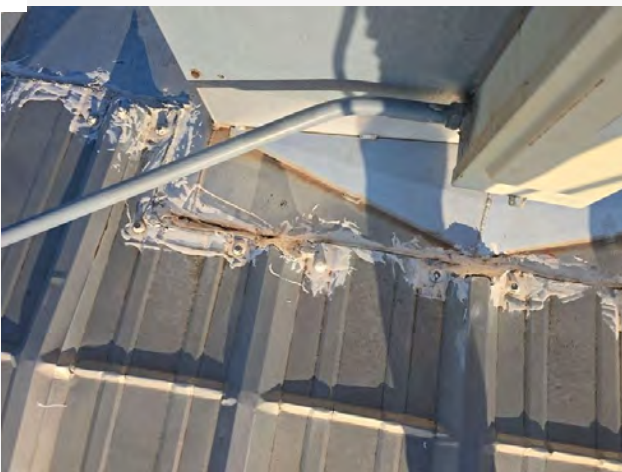
### Prior repairs

Prior repair requiring resealing.

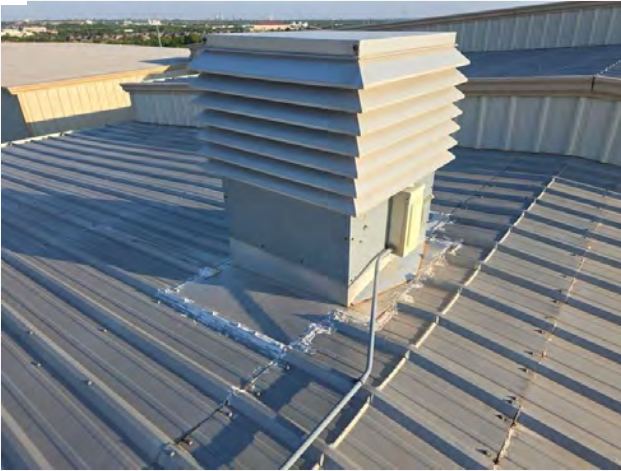
### Prior repairs

Prior repair requiring resealing.

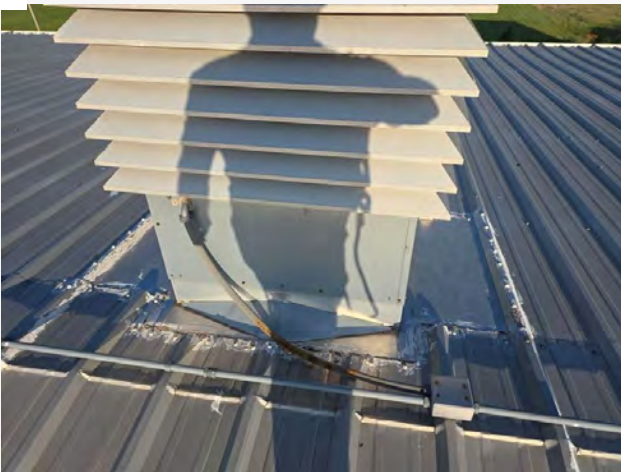
### Prior repairs

Prior repair requiring resealing.

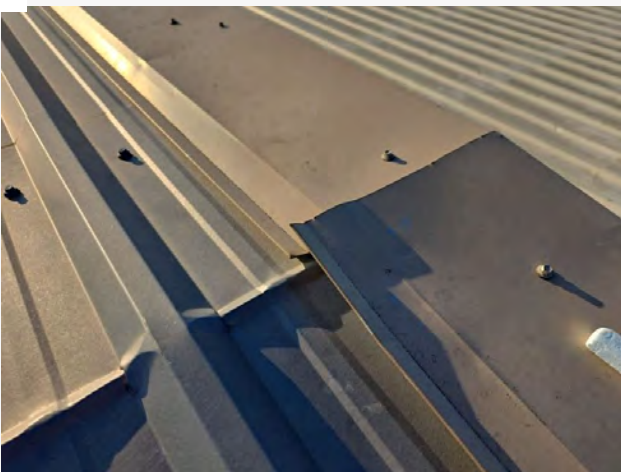
### Gable trim

Gable trim requiring repair.

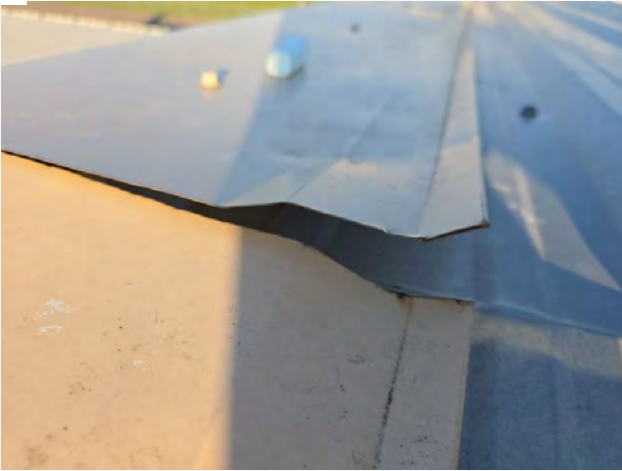
### **Gable trim**

Second view of the gable trim condition.

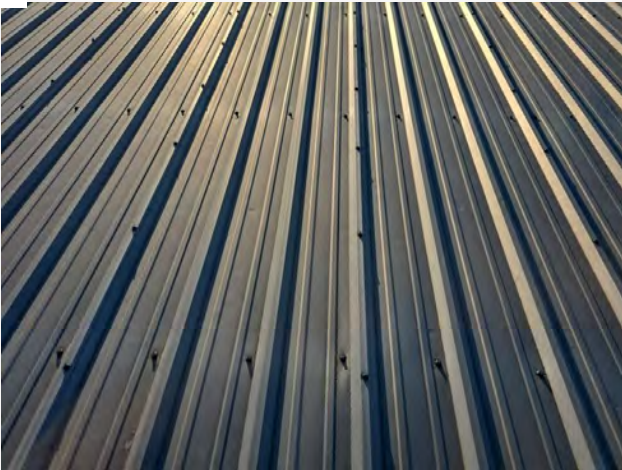
### **Hail impact**

Widespread hail impact across the section.

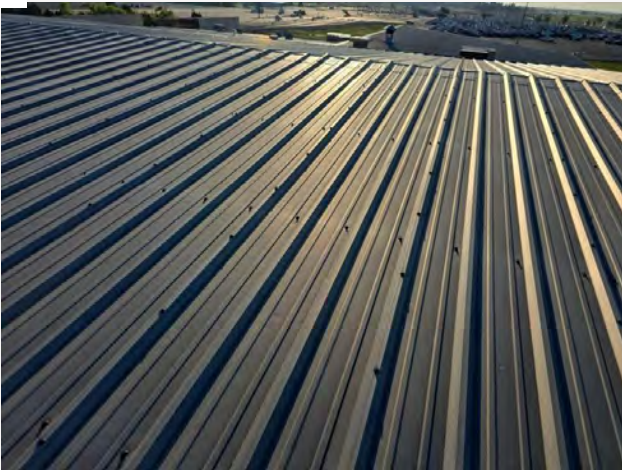
### **Hail impact**

Continued hail impact. Fastener repair is also required here.

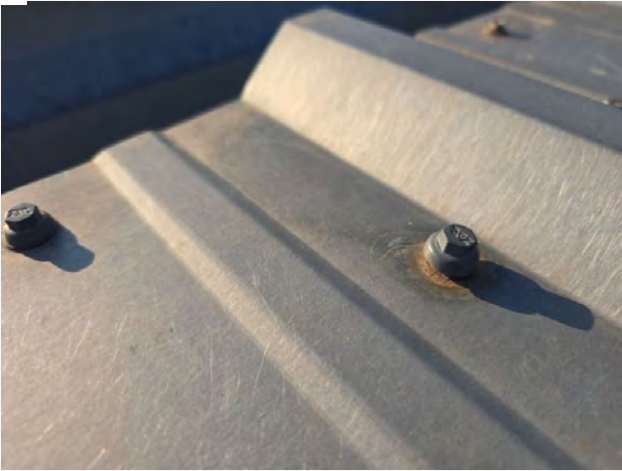
### Backed-out fastener

Fastener has backed out of the panel.

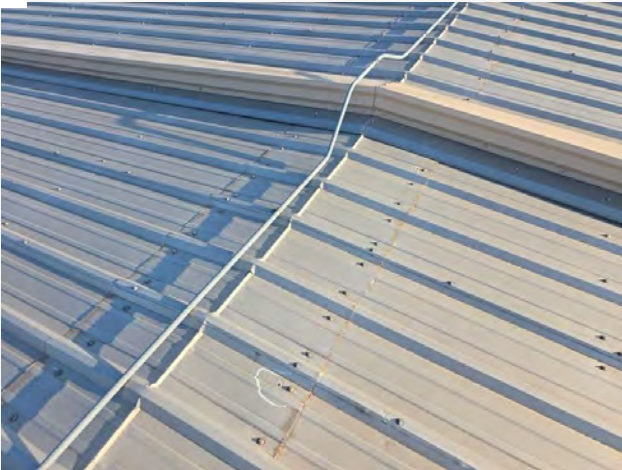
### Missing fastener

Location of a missing fastener.

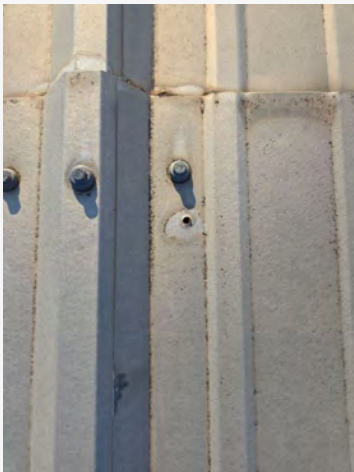
### Missing fastener

Second missing fastener location.

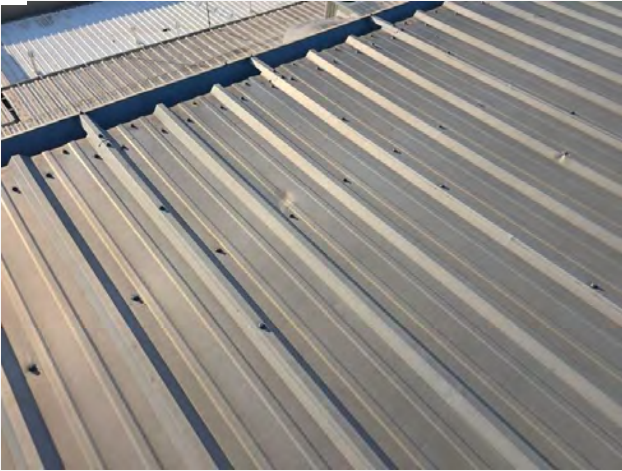
### Hail impact

Hail impact on the panel surface.

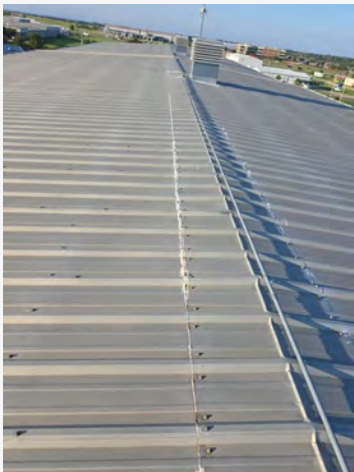
### Seam sealant condition

Seam was sealed previously. The sealant has gone chalky and is at the end of its service life.

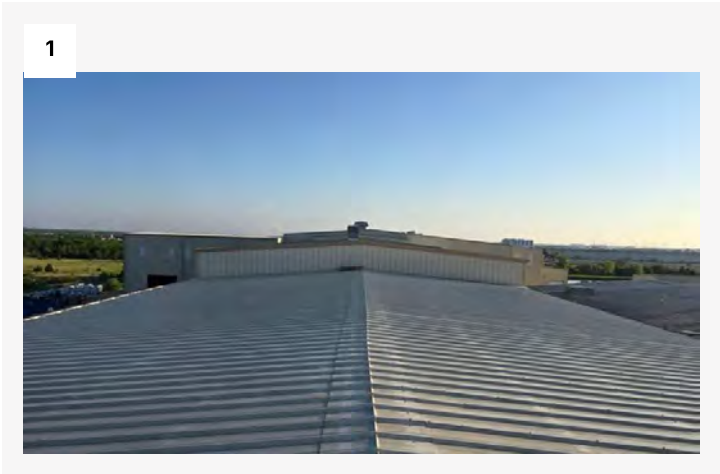
### Section overview

Overview of the section.

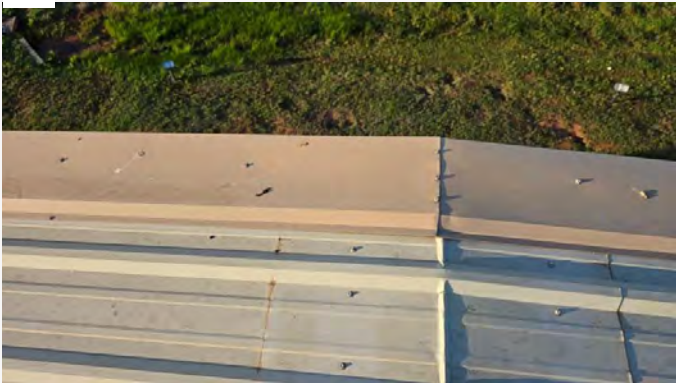
### Gable edge

Gable edge is in acceptable condition.

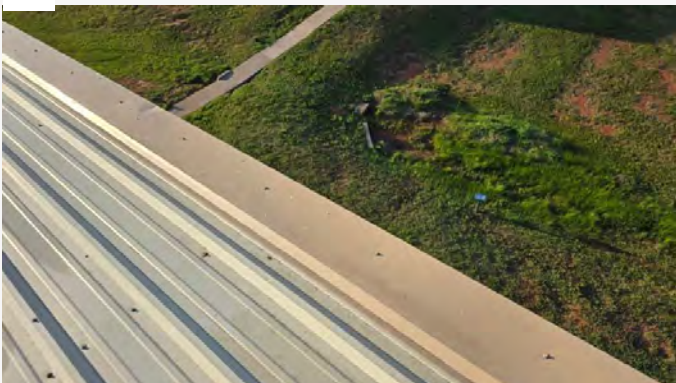
### Gable edge

Second view of the gable edge.

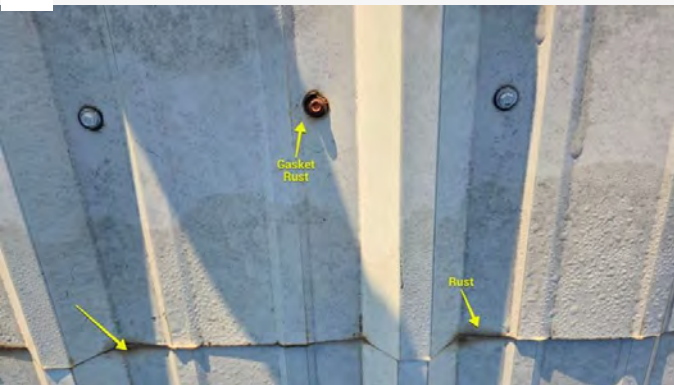
### Rust at panel seam

Rust at the panel seam with a faulty gasket at the same location.

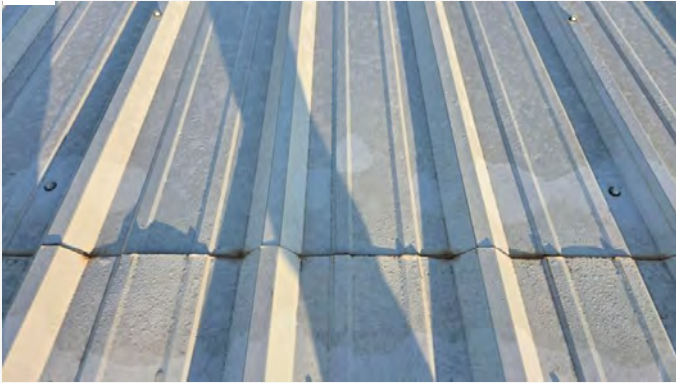
### **Rust at seam**

Second location of seam corrosion.

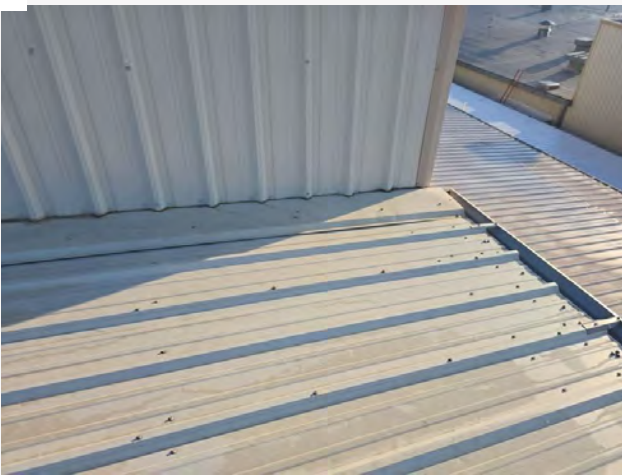
### **Adjacent section transition**

Transition to the adjacent section is in good order.

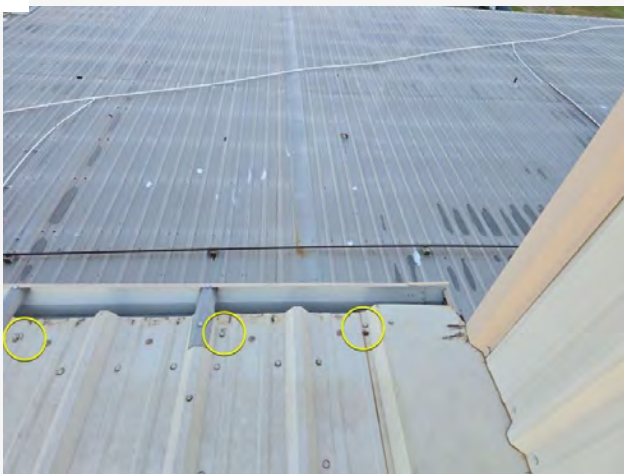
### Edge condition

Condition issues at the edge of the area.

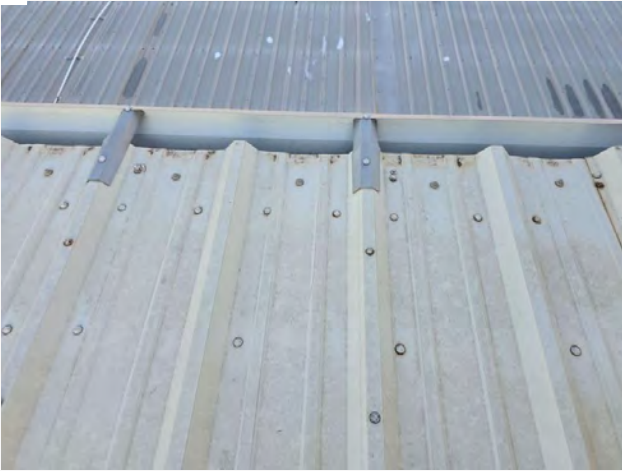
### Edge condition

Edge requiring closer evaluation.

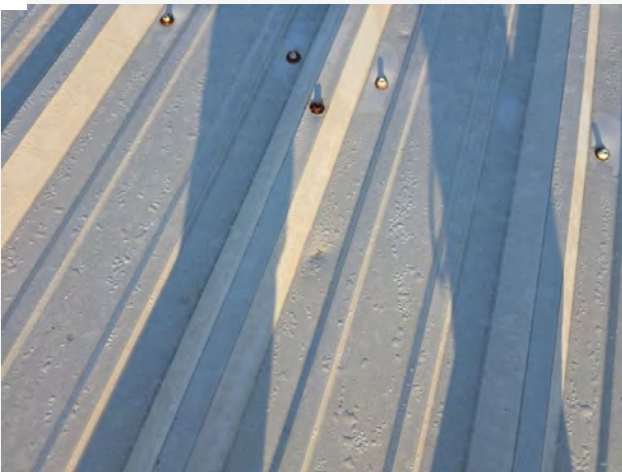
### Rusted fastener

Second rusted fastener, with hail impact visible nearby.

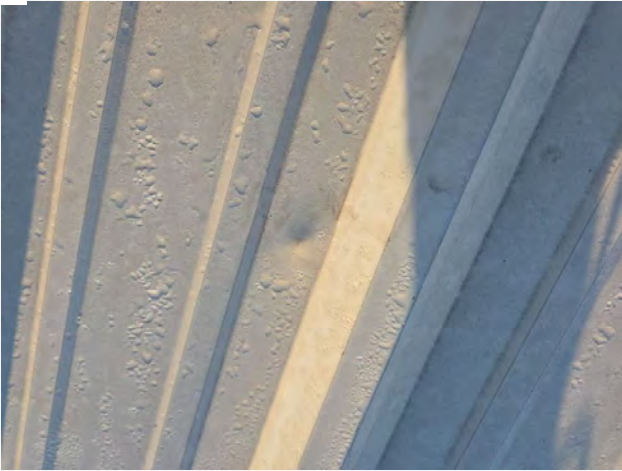
### Hail impact

Hail impact on the panel surface.

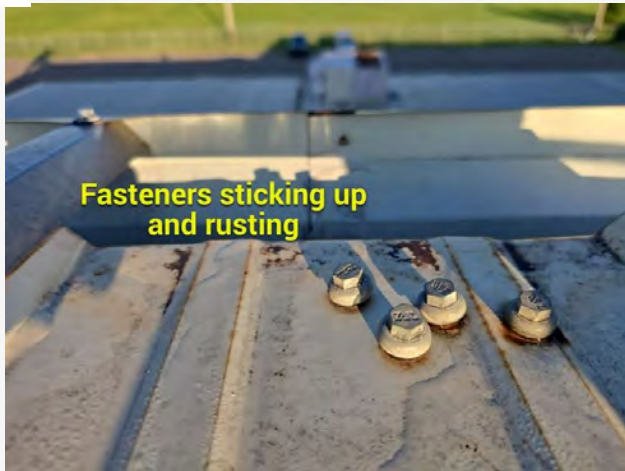
**Fastener condition**

Final fastener documentation for this section.
