# Thermal Inspection Report

Aerial Thermal and On-Roof Assessment

## Sample Thermal Inspection Property

Inspection date: November 4, 2025

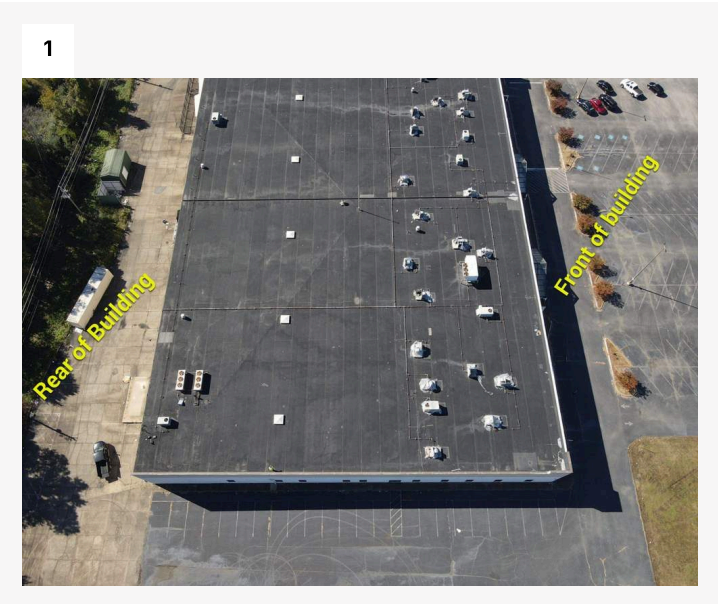
**Image 1**  
Northeast end of the building, visual reference image. Building front is to the right, rear to the left.

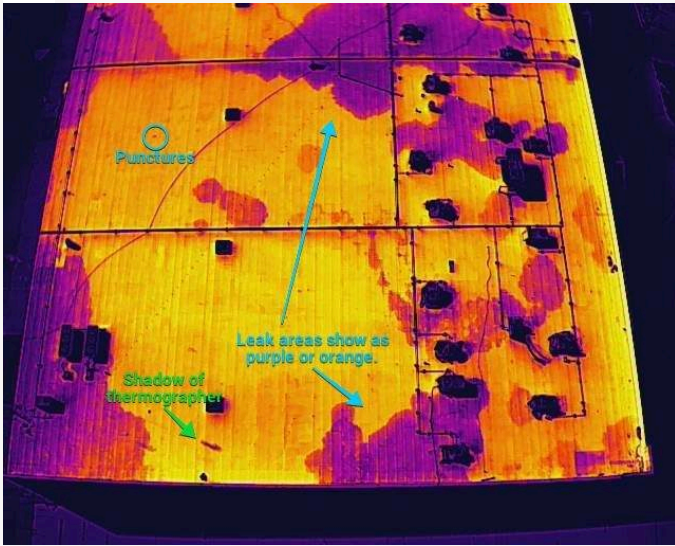
### Image 1 (Thermal)

Northeast end, thermal. Dry roof reads yellow. Cool purple areas indicate water in the insulation below the membrane. One puncture is annotated at upper left. The dark shape at lower left is the thermographer's shadow, not an anomaly.

Multiple punctures observed. One is annotated in Image 1 (Thermal). A full count was not taken during this inspection.

**Recommended action:** Count and map the punctures, then compare their locations against the wet areas below.

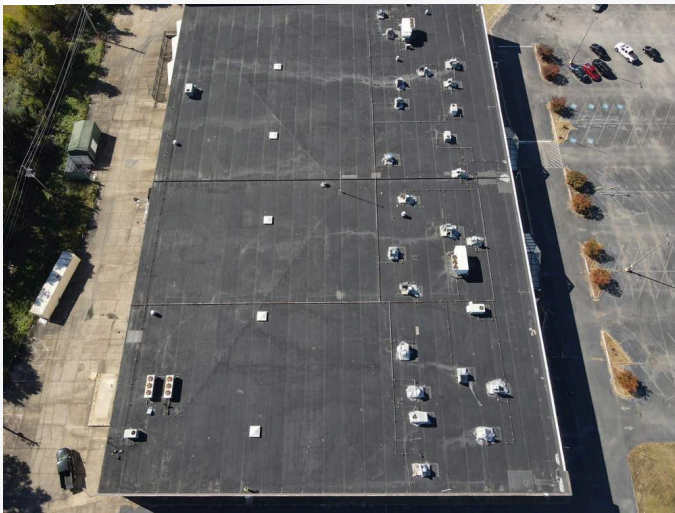
### Image 2

North-central roof area, visual reference image.

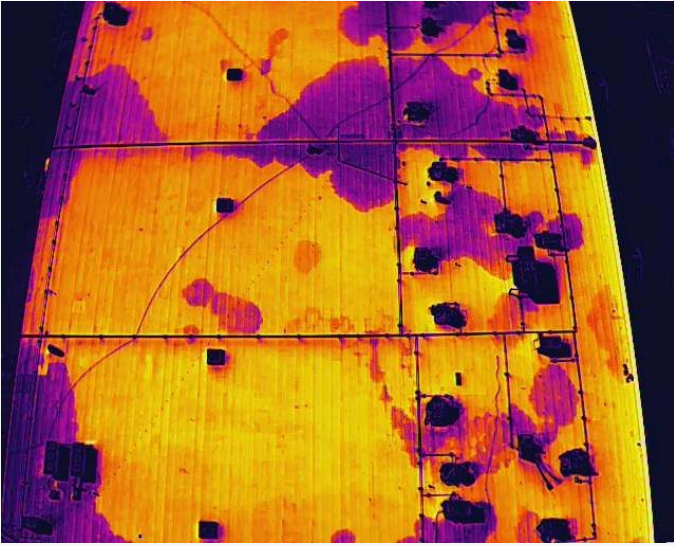
### Image 2 (Thermal)

North-central roof area, thermal. Large connected cool areas cross insulation board joints, which indicates widespread subsurface moisture rather than isolated wet boards.

Cool areas span multiple insulation boards without a clear boundary. Confirmed wet by core cut to the metal deck, wet at all levels, with saturated fiberboard.

**Recommended action:** Treat as saturated. Scope replacement or full tear-off of this area. Spot repair is not a reasonable fix at this extent.

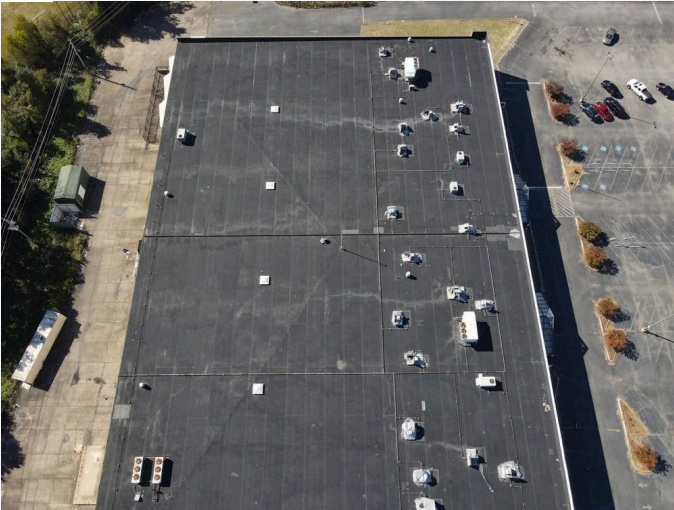
### Image 3

North roof area continuing west, visual reference image.

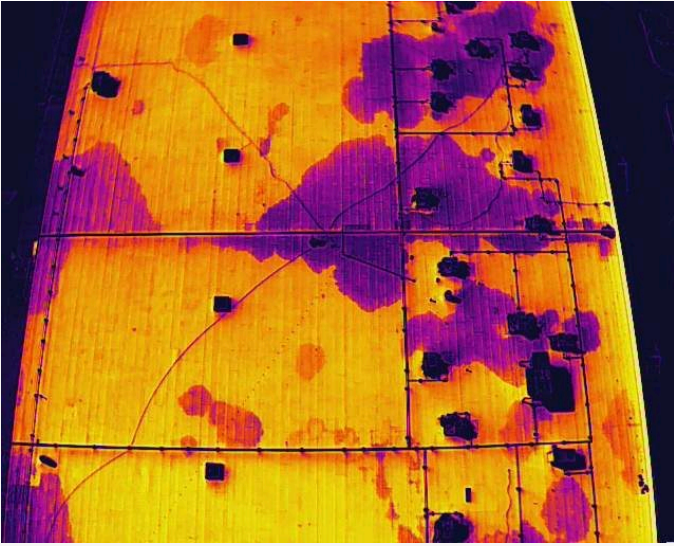
### Image 3 (Thermal)

North roof area, thermal. Cool areas continue across the section with no clear boundary between them.

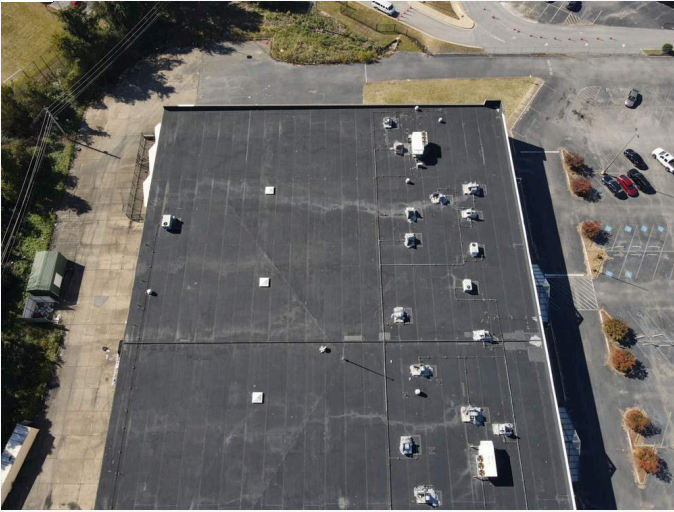
### Image 4

West end of the north roof area, visual reference image.

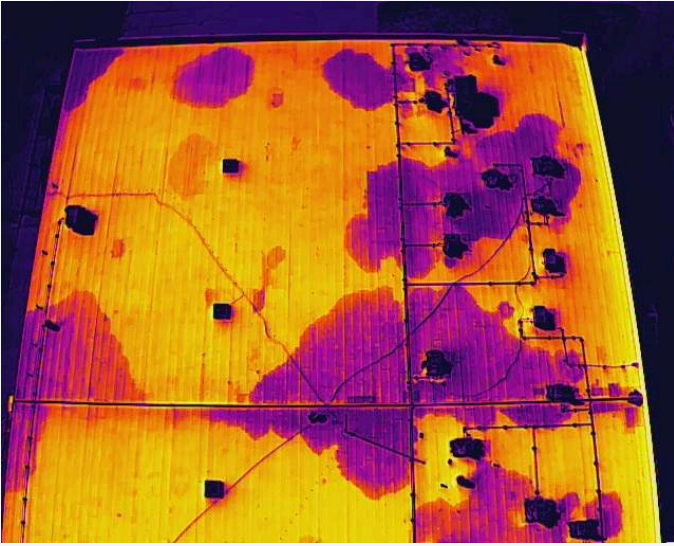
#### Image 4 (Thermal)

West end of the north roof area, thermal. Moisture indications extend to the roof perimeter in several places.

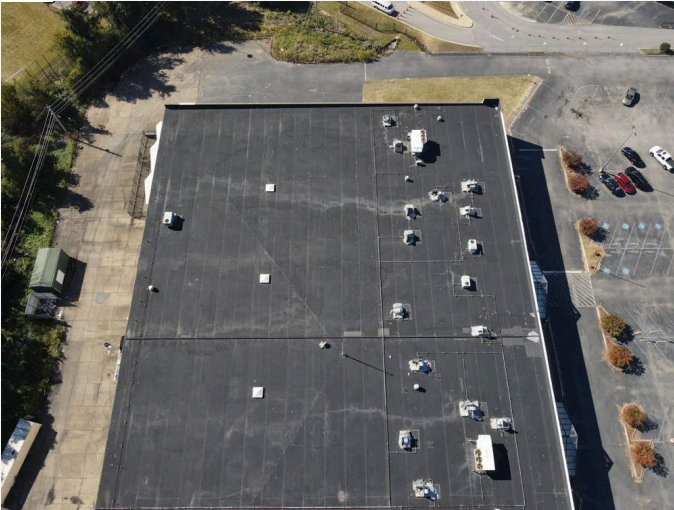
#### Image 5

Center roof area, visual reference image.

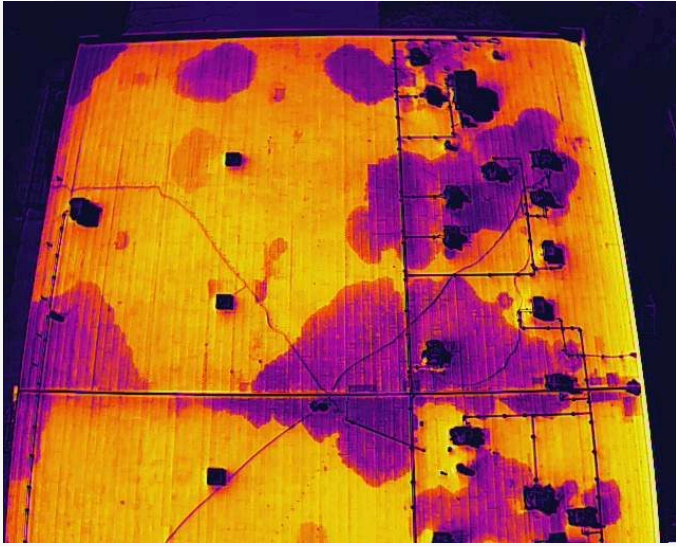
#### Image 5 (Thermal)

Center roof area, thermal. Cool areas run through the middle of the roof and connect to the north section indications.

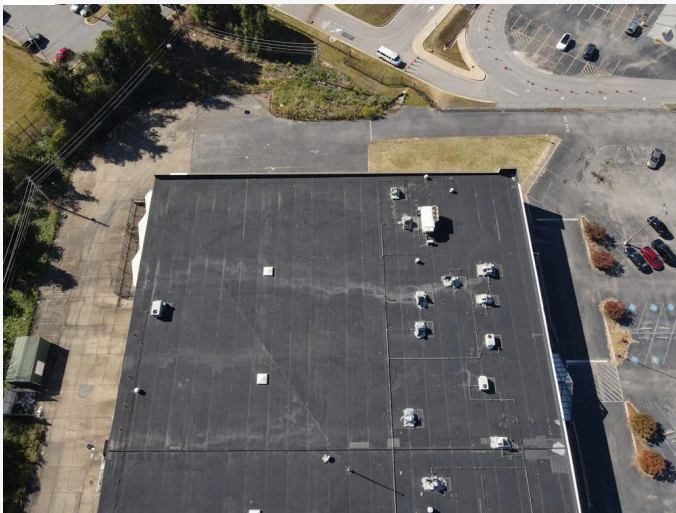
#### Image 6

Center roof area, visual reference image for the detail that follows.

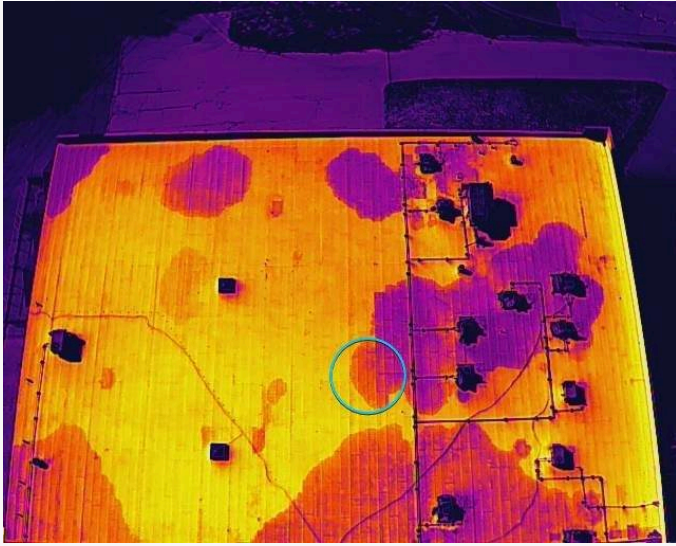
### Image 6 (Thermal)

Center roof area, thermal. The circled area is shown in detail in Images 13 and 14.

Moisture is visible on the metal deck itself, decreasing to the left across the low rib and stopping at the rib. This indicates intrusion through every layer of the assembly.

**Recommended action:** Core cut to confirm deck condition and check for corrosion. Deck condition changes the repair decision.

Second, core the center area circled in Image 6 where moisture reads on the metal deck. Deck corrosion changes the repair decision and the budget.

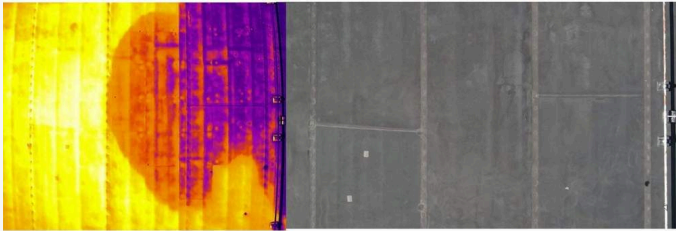
### Image 6 detail, side by side

The same location shown side by side, thermal on the left and visual on the right. The underlying metal deck is visible in the right image. Moisture reads on the metal deck itself, which indicates intrusion at all levels of the roof assembly.

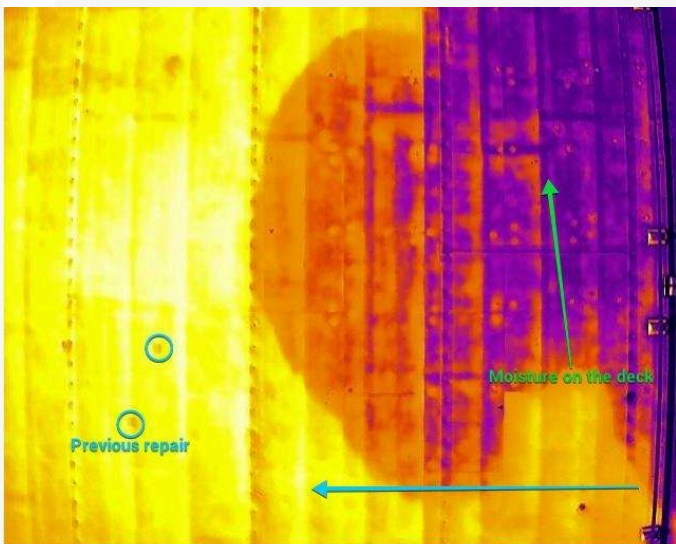
### Image 6 detail, close up

Close up of the same location. Moisture is heaviest on the right and decreases moving left. Yellow is largely dry. Moisture on the deck stops at the low rib. Purple, indicating moisture, sits on the right side of the rib. The area on the left side of the rib is drier. A previous repair is circled at left.

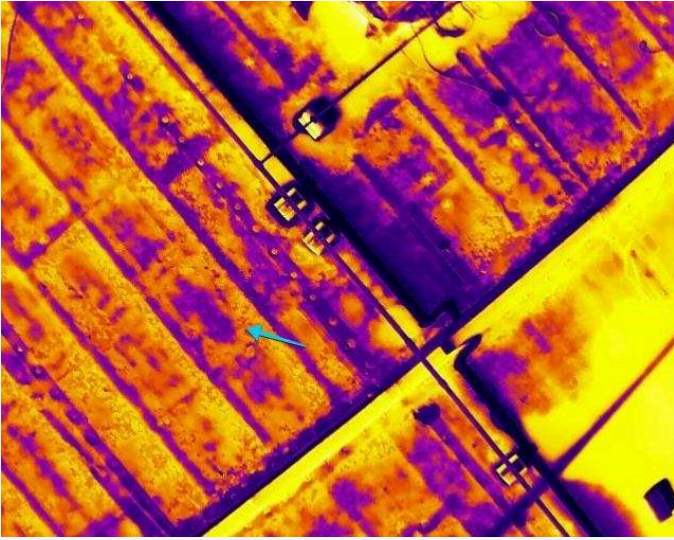
### **Ponding**

Water ponding on the roof surface, which indicates saturation of the roof material below. No subsurface reading is possible through standing water, so this area is excluded from subsurface interpretation. Flight height 62 feet, gimbal at 90 degrees.

Water standing on the surface. The ponding itself is confirmed. No subsurface reading is possible through standing water, so the condition below this area is unknown.

**Recommended action:** Check drainage at this location and re-scan once dry.

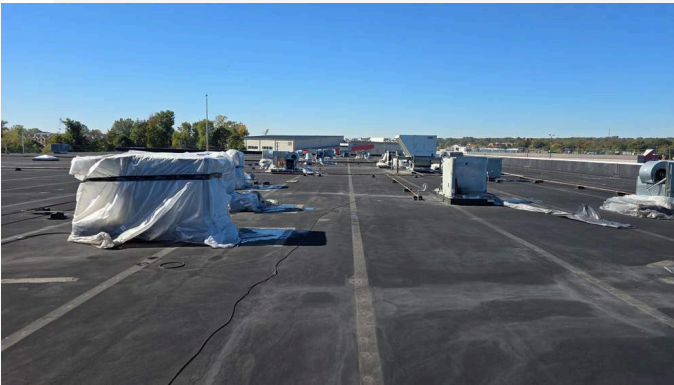
### HVAC units

Rooftop HVAC units, several dismantled and covered.

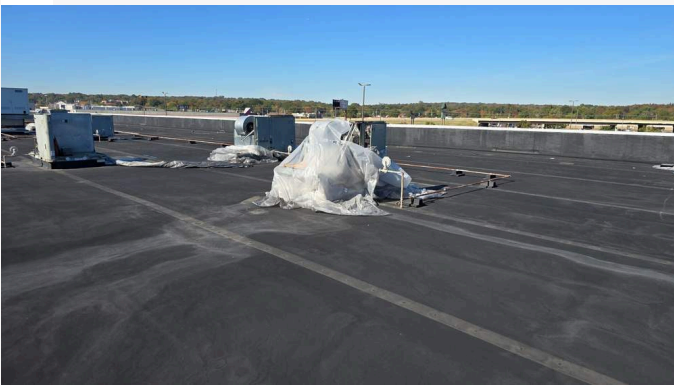
### HVAC units

Additional rooftop HVAC units in the same condition.

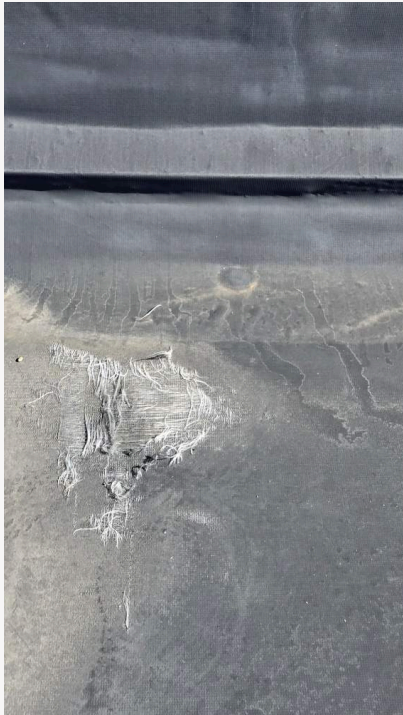
#### **Scrim failure**

EPDM worn through to the reinforcing scrim.

**Recommended action:** Document and map each location. Treat as active entry points.

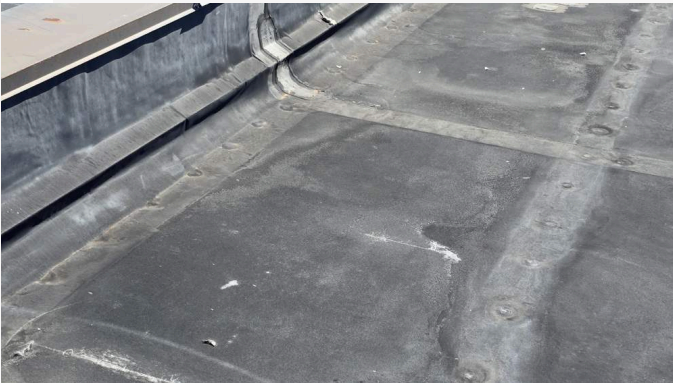
#### **Scrim failure**

Scrim exposure near a curb and transition detail.

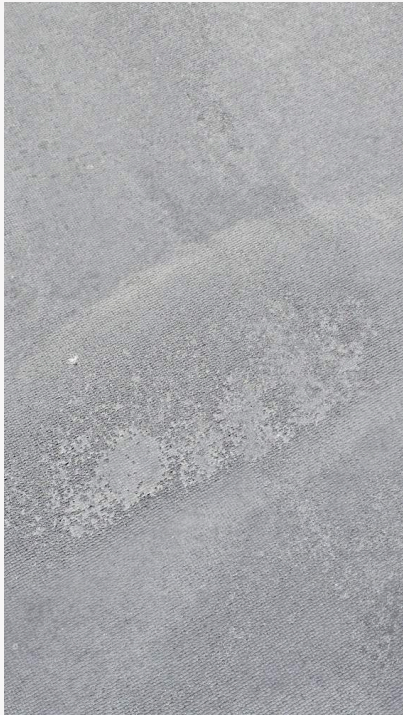
### **Scrim failure**

Scrim exposure in the open field of the membrane.

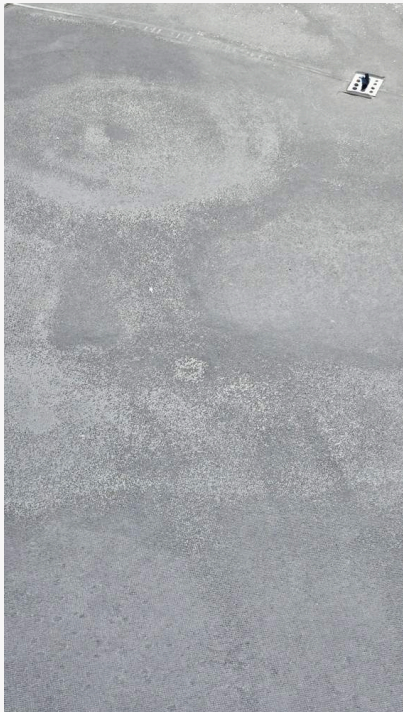
### **Scrim failure**

Scrim exposure with surrounding weathering and surface deterioration.

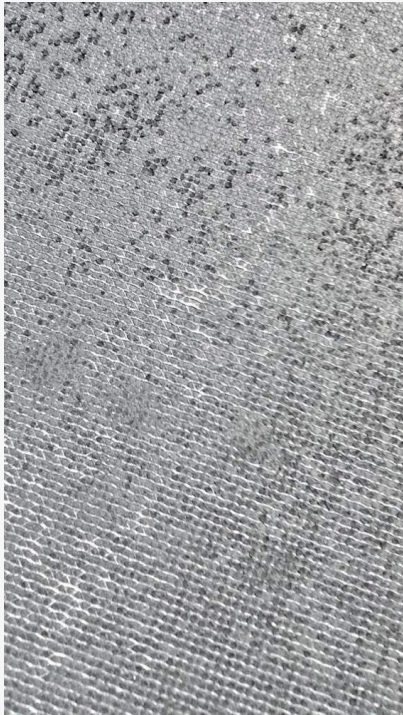
### **Scrim failure**

Close up of exposed scrim. The reinforcing grid is fully visible, meaning the top ply of the EPDM is gone at this location.

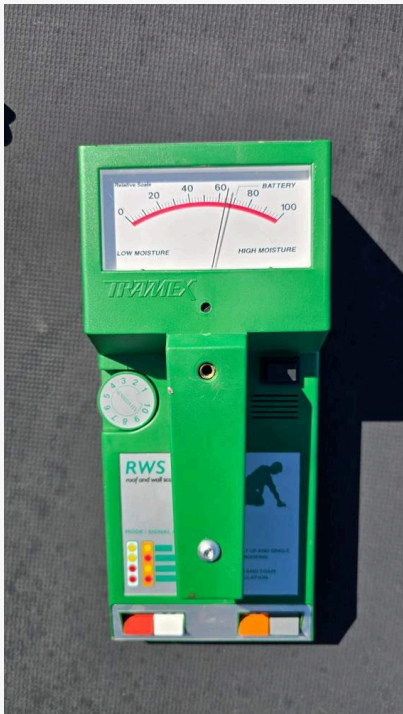
## Impedance scan

Tramex RWS reading confirming moisture in an area identified by the thermal drone scan.

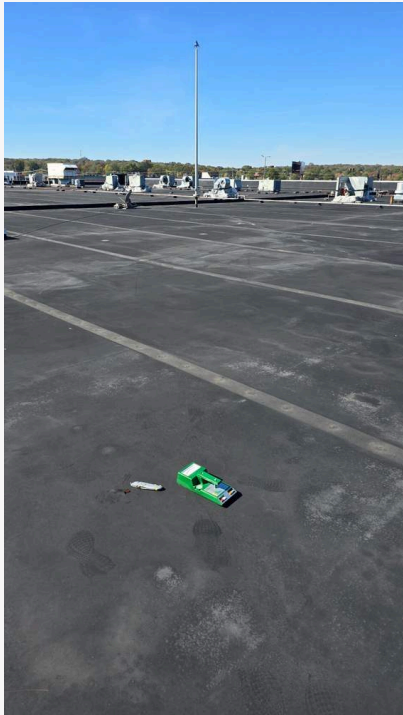
### Impedance scan

Tramex RWS in position on the roof at a thermal indication, showing the area tested.

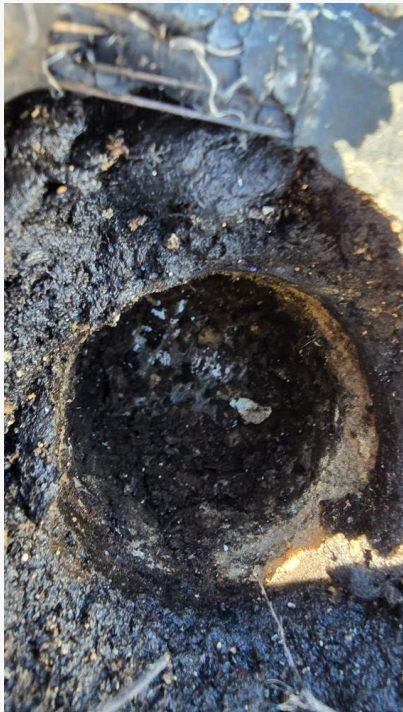
### Core cut

Core cut. The roof was wet at all levels. Metal decking observed at the base of the core. Total assembly depth 3.5 inches.

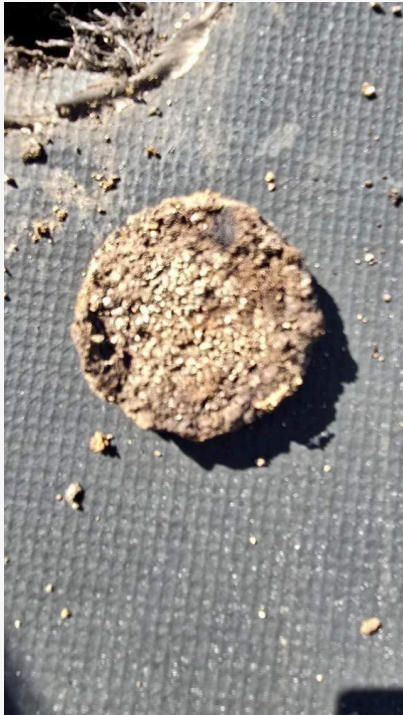
### Core sample

Core sample showing the original modified bitumen BUR. This roof carries two systems, a modified bitumen BUR with a recover of fiberboard and EPDM over it.

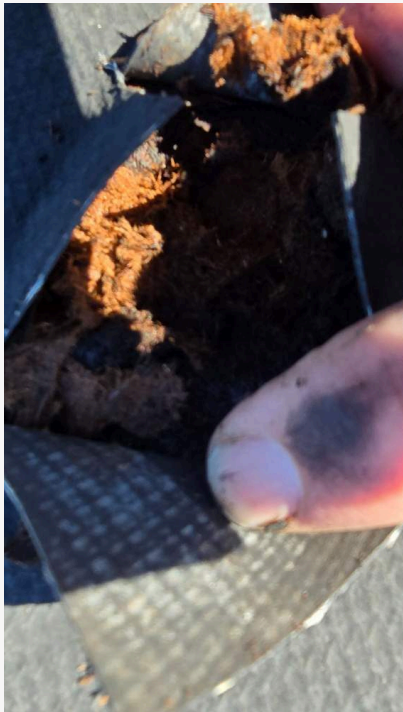
### Spot check 1

Spot check confirming the impedance and thermal indications of water. The fiberboard is completely saturated.

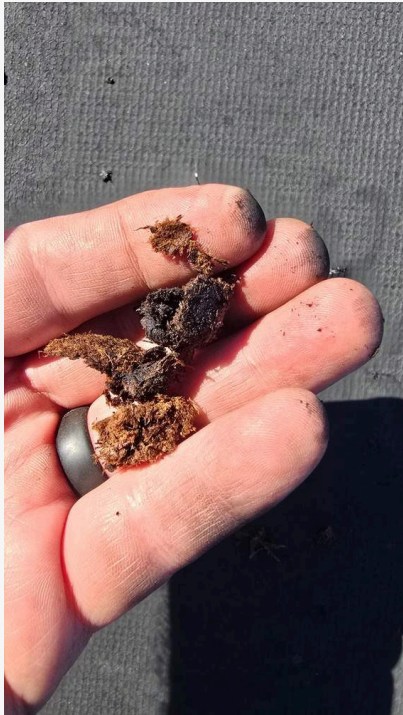
### Spot check 1, sample

Saturated and deteriorated fiberboard removed from the spot check. The board has lost its structure and no longer provides usable insulation value or substrate support.

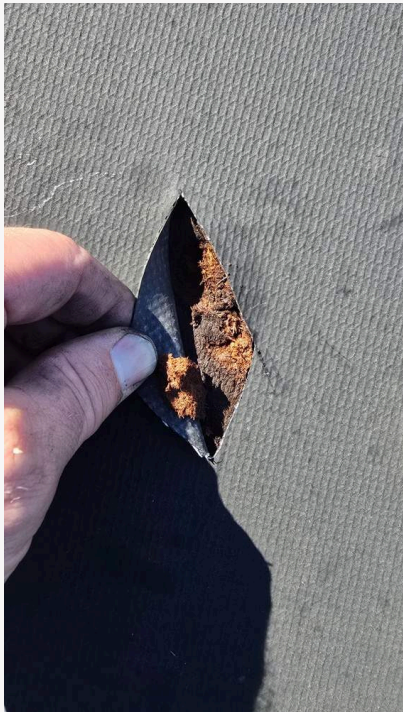
### Spot check 2

Second spot check at an identified leak area, confirming saturated fiberboard below the membrane.
