ROOF MRI

BIG BOX SAMPLE STREET, ANYWHERE USA

OVERVIEW

METHOD(S): **ROOF MRI**
PIN PRICK + IMPEDANCE

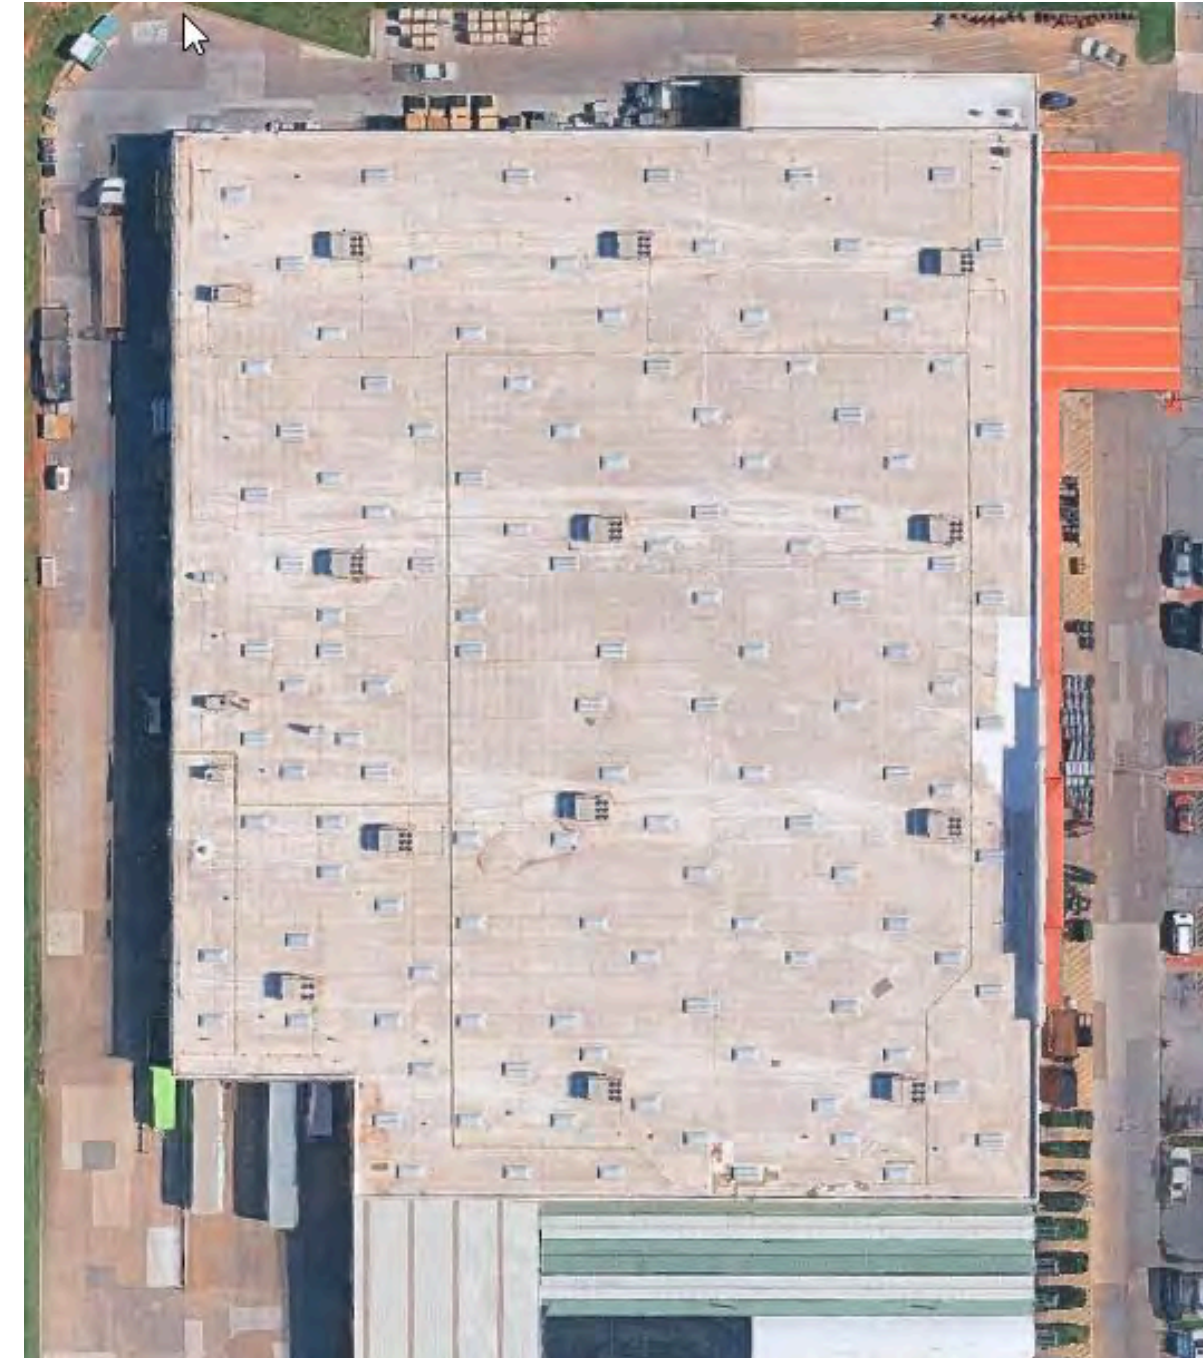
BIG BOX SAMPLE STREET, ANYWHERE USA

TOTAL SQUARES: 1,040 | 100SF EACH

MOISTURE ANALYSIS:	WET 10,800SF (10%)	 
	DAMP 2,000SF (2%)	 
	DRY 91,200SF (0%)	 
	UNDETERMINED 0SF (0%)

A scan of this 104,000 SF roof section identifies active and developing moisture conditions across portions of the insulation layer, with 10% of the scanned area classified as wet and 2% categorized as damp, bringing the combined moisture presence to 12% of the total scanned surface. The remaining 88% of the roof returned dry readings, indicating that the majority of the system is currently in stable condition. No areas were left undetermined, confirming complete scan coverage of the section. While the combined affected area represents a relatively contained percentage of the overall roof, the scale of this section means that 12,800 SF of insulation is currently carrying measurable moisture conditions that require prompt attention. A comprehensive dry-out plan is recommended to address the active wet zones and developing damp areas before further migration into the surrounding dry insulation compromises a larger portion of this extensive roofing system.

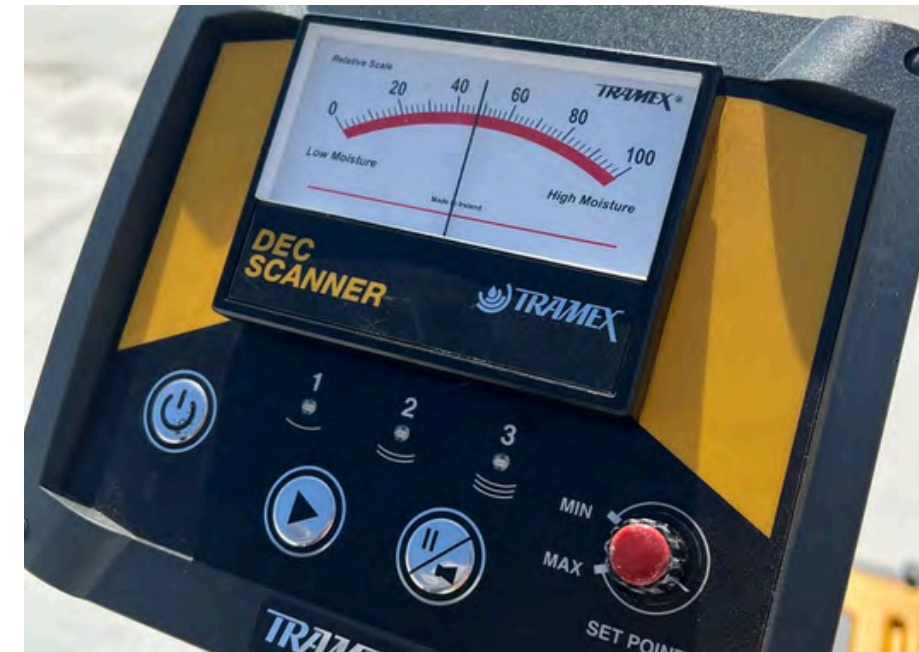
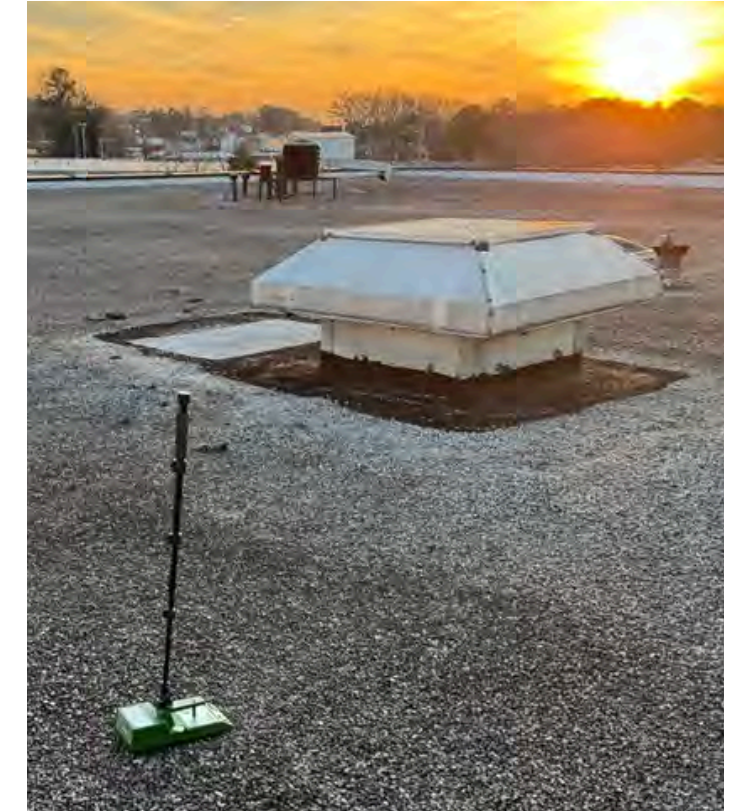
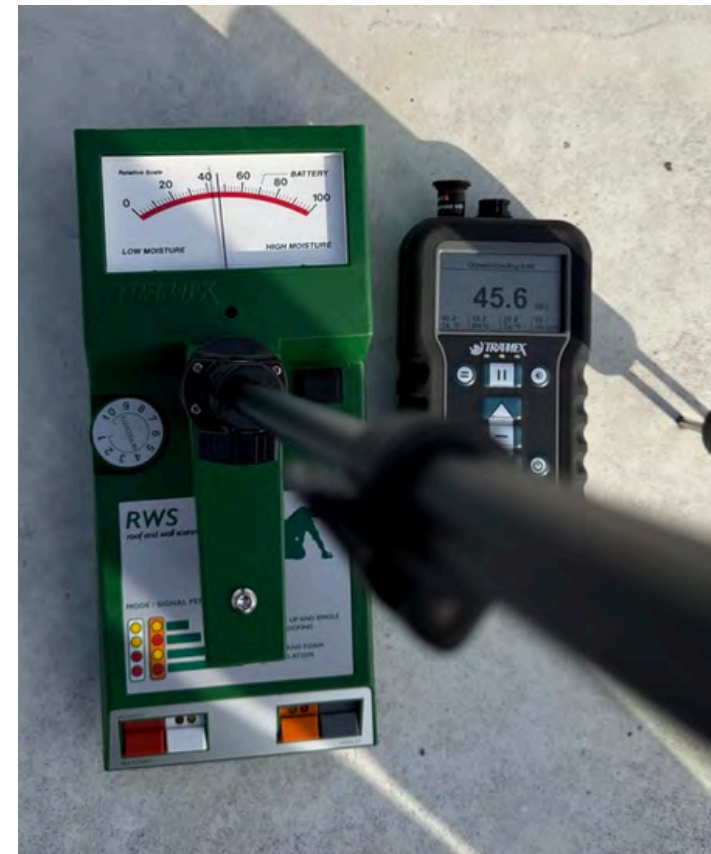
ROOF MRI PROCESS

Asset Roof used the most professional equipment and methods to locate and confirm moisture percentages. A Tramex DecScanner was utilized to detect moisture without penetrating the roof system. Using an Impedance Scanner is one of the primary ways to detect moisture in roofs and walls without penetrating the roof.

A Tramex MEX5 moisture probe was utilized to confirm moisture readings and to calibrate the Tramex. This is a preferred method for ensuring the non-destructive testing is as accurate as possible. Test is in accordance with ASTM Standards for non-destructive testing.
