**AssetRoof**

# **Roof Condition Assessment**

**Metal Roof System — Seven Sections**

## **Sample Industrial Facility**

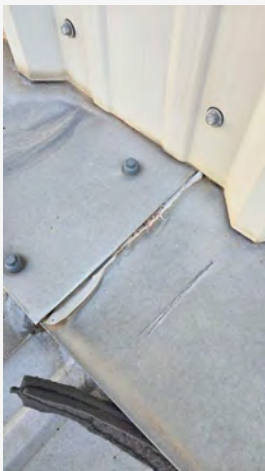
6

#### **Closure and sealant failure**

Foam closure displaced, with sealant failure at the flashing seam above it.

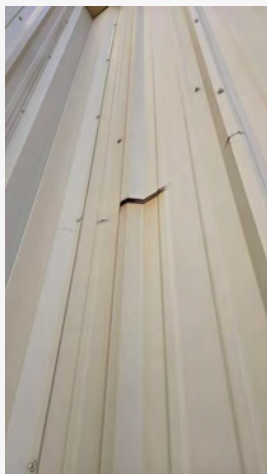
12

### Wall penetration

Hole in the vertical wall surface.

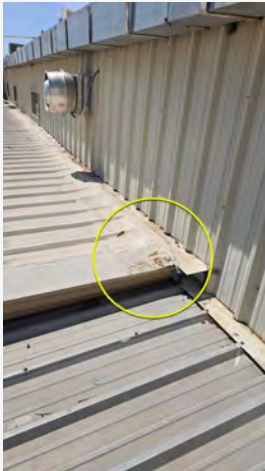
6

### Coating degradation

Sprayed polyurethane foam breaks down under UV exposure. The coating is the sacrificial layer that protects it, so once the coating thins, the foam itself begins to weather.

Section 2. The coating is the sacrificial layer. Once it is gone the foam degrades quickly, and recoating becomes replacement.

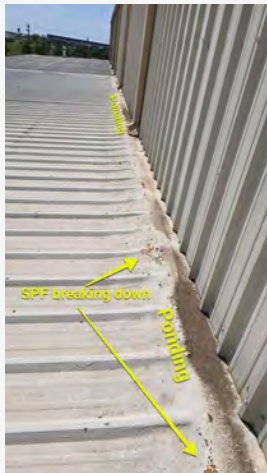
12

### Drainage against the wall

Sprayed foam applied at this transition has interrupted drainage, which is holding water against the building.

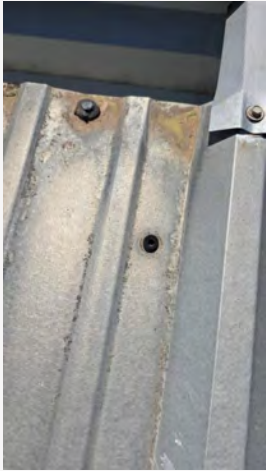
14

### Missing fastener

Missing fastener in the panel field.

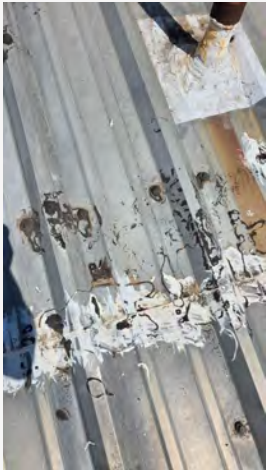
15

### Prior repair

Prior repair requiring cleanup and evaluation for whether it is still performing.

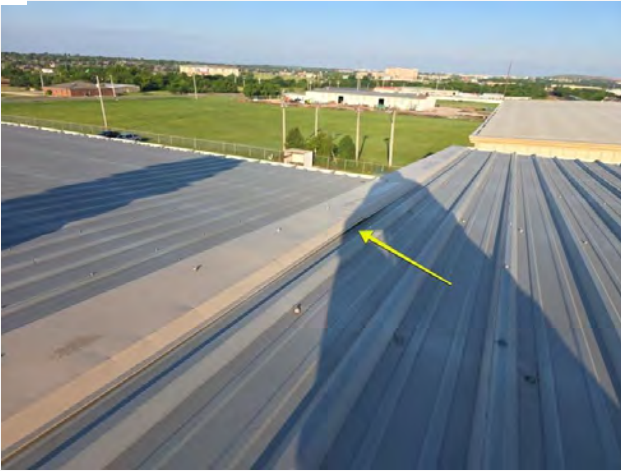
7

### Wind uplift exposure

Lifted gable trim represents a wind uplift exposure. Edge metal is the first thing a wind event takes.

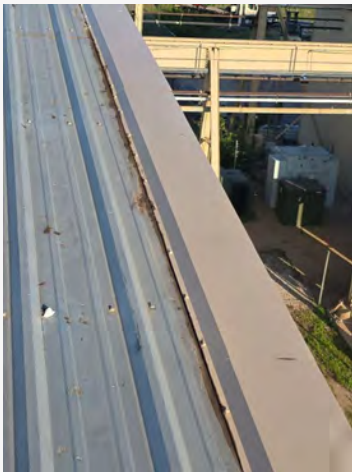
12

### Gable detail, northeast

Gable detail at the northeast side. The prior repair here should be verified as functional.

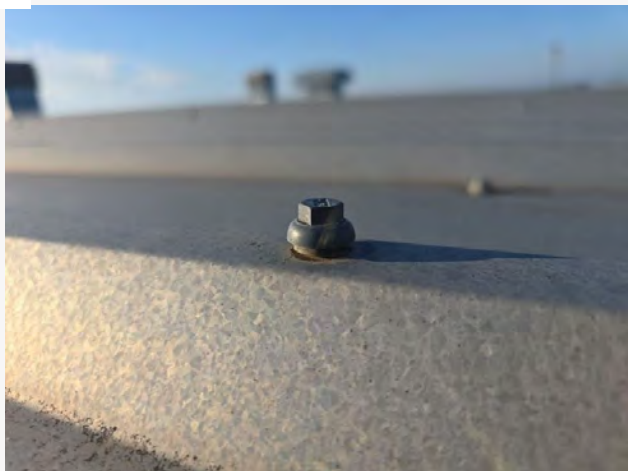
25

### **Backed-out fastener**

Second backed-out fastener.

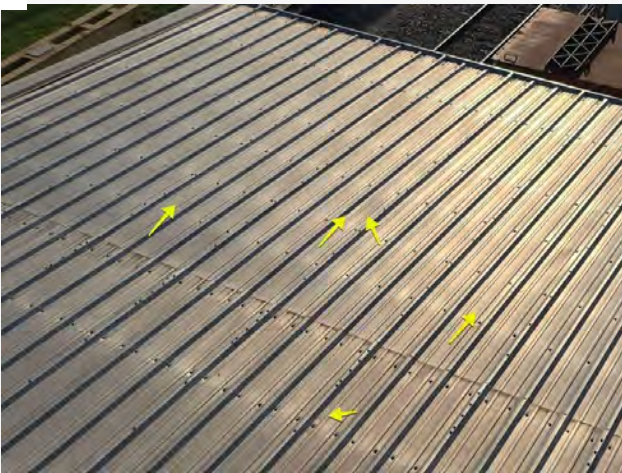
4

### Hail impact

Hail impact identified across this section.

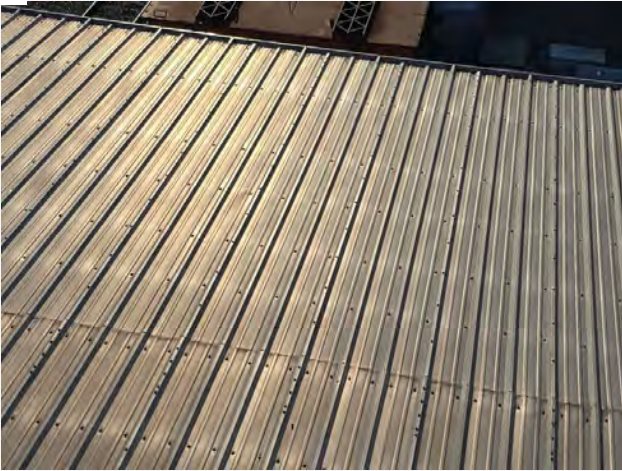
5

### Hail impact

Second view of hail impact on the panel surface.

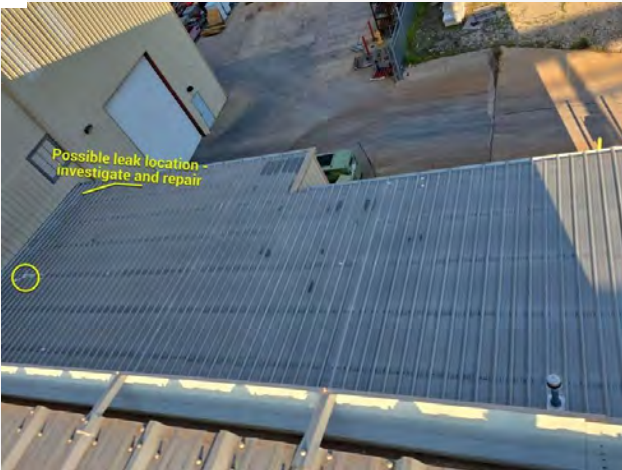
6

### Hail impact

Third view. The pattern is consistent across the section rather than localized.

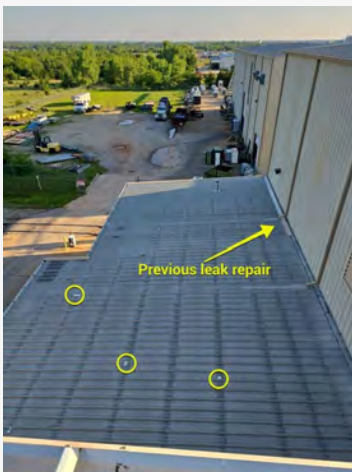
7

### Transition repair

Prior leak repair at the bird stop. This transition continues to leak and requires a corrective detail rather than another patch.

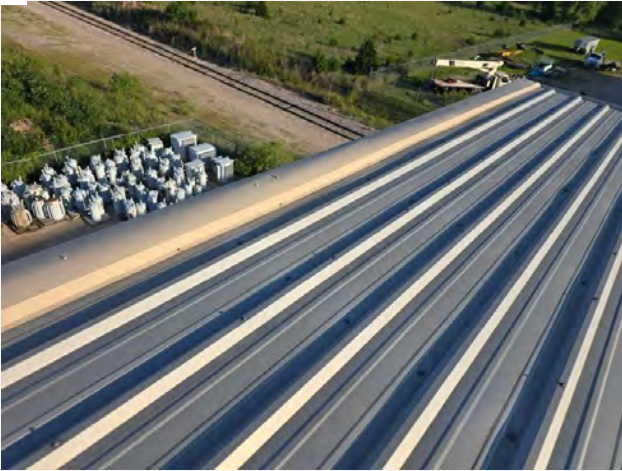
5

### Panel uplift

Uplift along the reversed panel.

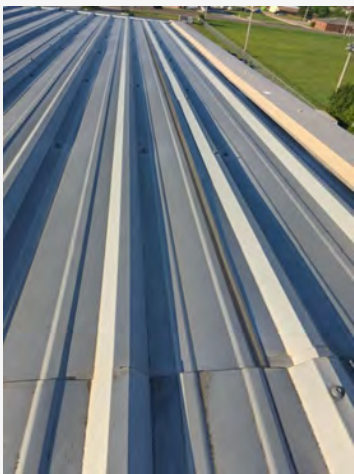
7

### Corner separation

Separation at the corner where this section meets the adjacent section, leaving an open gap.

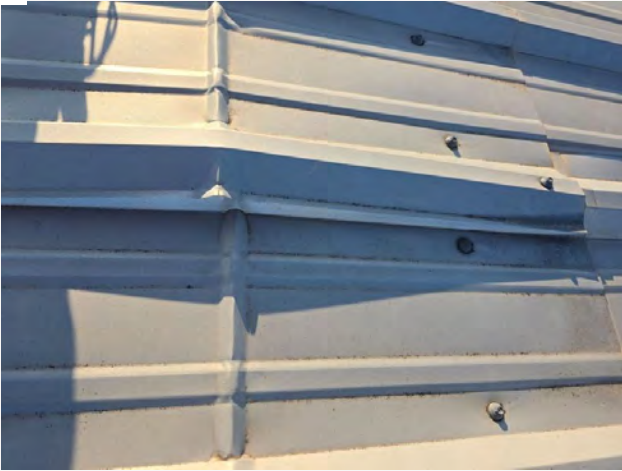
8

### Corner separation

Second view of the corner gap.

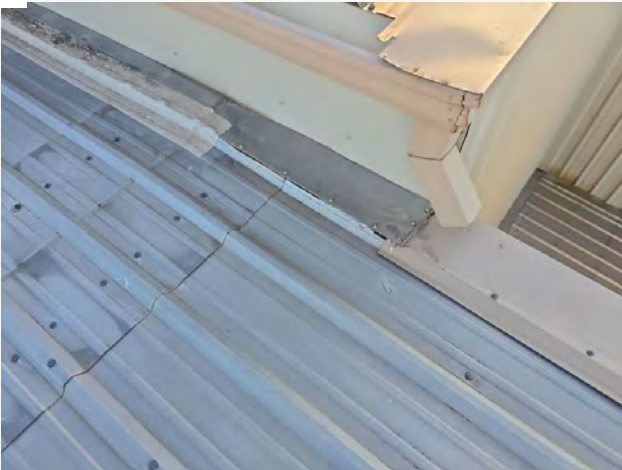
9

### Corner separation

Third view showing the extent of the separation.

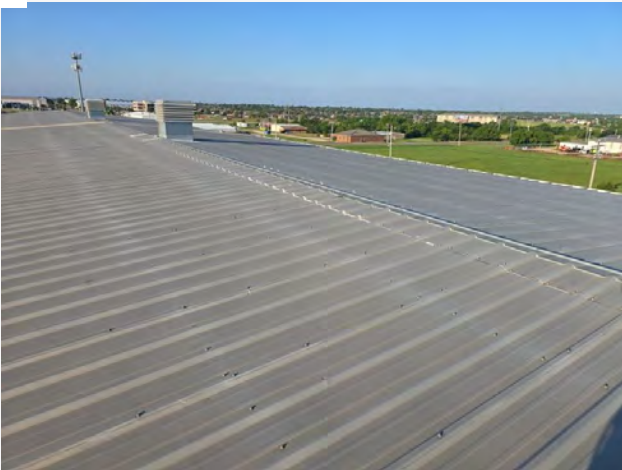
21

### Hail impact

Continued hail impact.

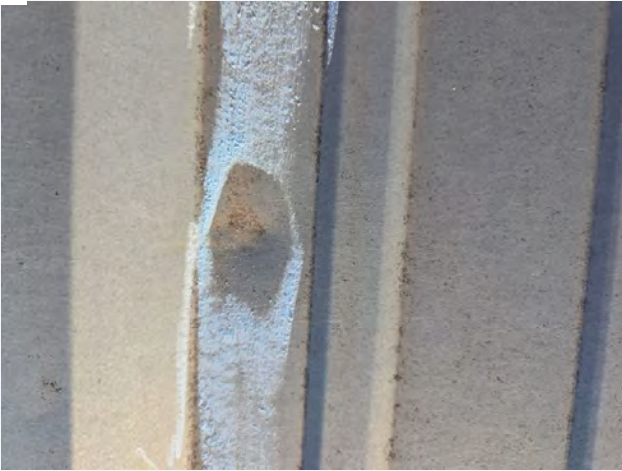
23

### Hail impact

Hail impact at the seam.

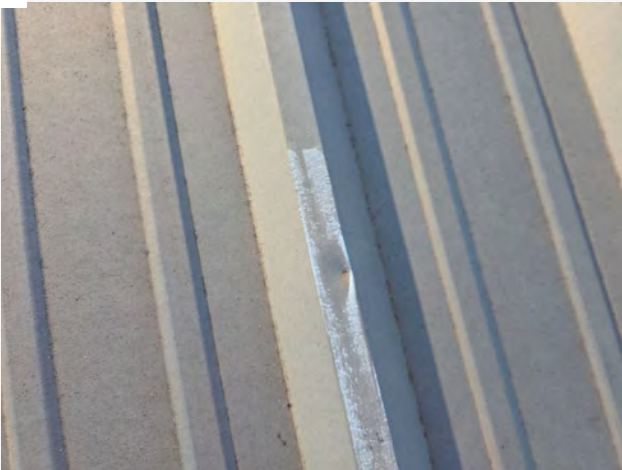
24

### Hail impact

Hail impact on the panel field.

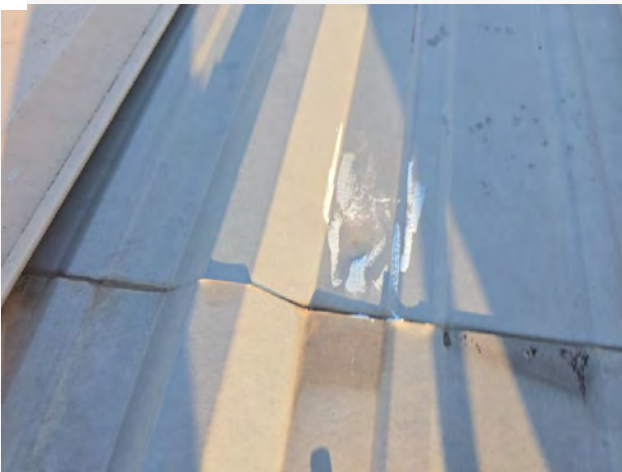
25

### Hail impact

Final hail documentation for this section.

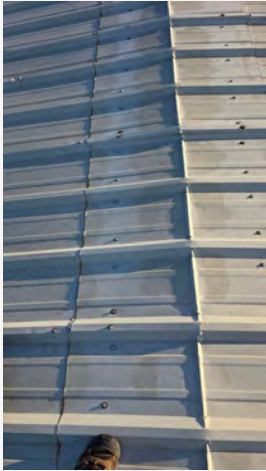
2

### Early fastener corrosion

Fasteners are beginning to rust across the section. Not yet critical, but this is the condition to track between inspections.

- Replace the faulty gasket and treat corrosion at the identified panel seams
- Replace or reseal backed-out and missing fasteners
- Track fastener corrosion against this record at the next inspection

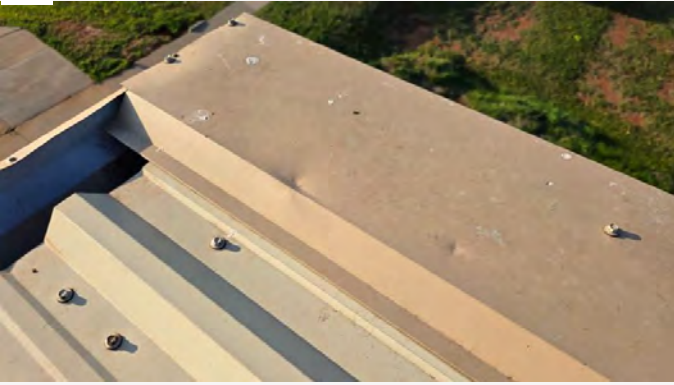
5

### Hail at gable edge

Hail impact visible on the gable edge metal.

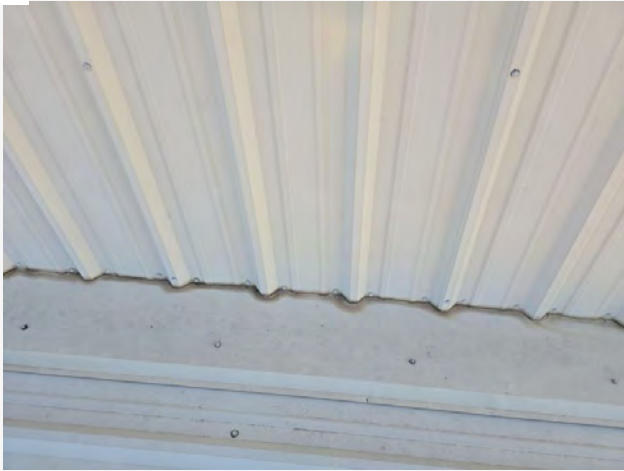
11

### Adjacent section transition

Second view of the transition.

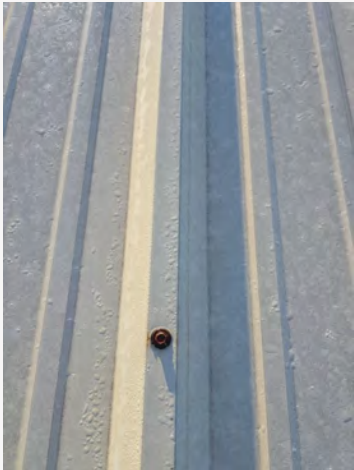
18

### Rusted fastener

Third rusted fastener.

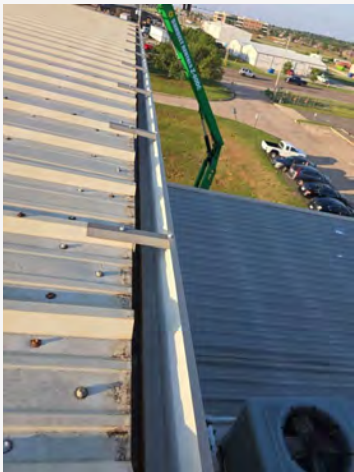
19

### Fastener condition

General fastener condition across the section.
